**BRANDON  
UNIVERSITY**

**John R. Brodie Science Centre**  
Preliminary Assessment & Conceptual Design Recommendations  
for Brandon University

February 2019

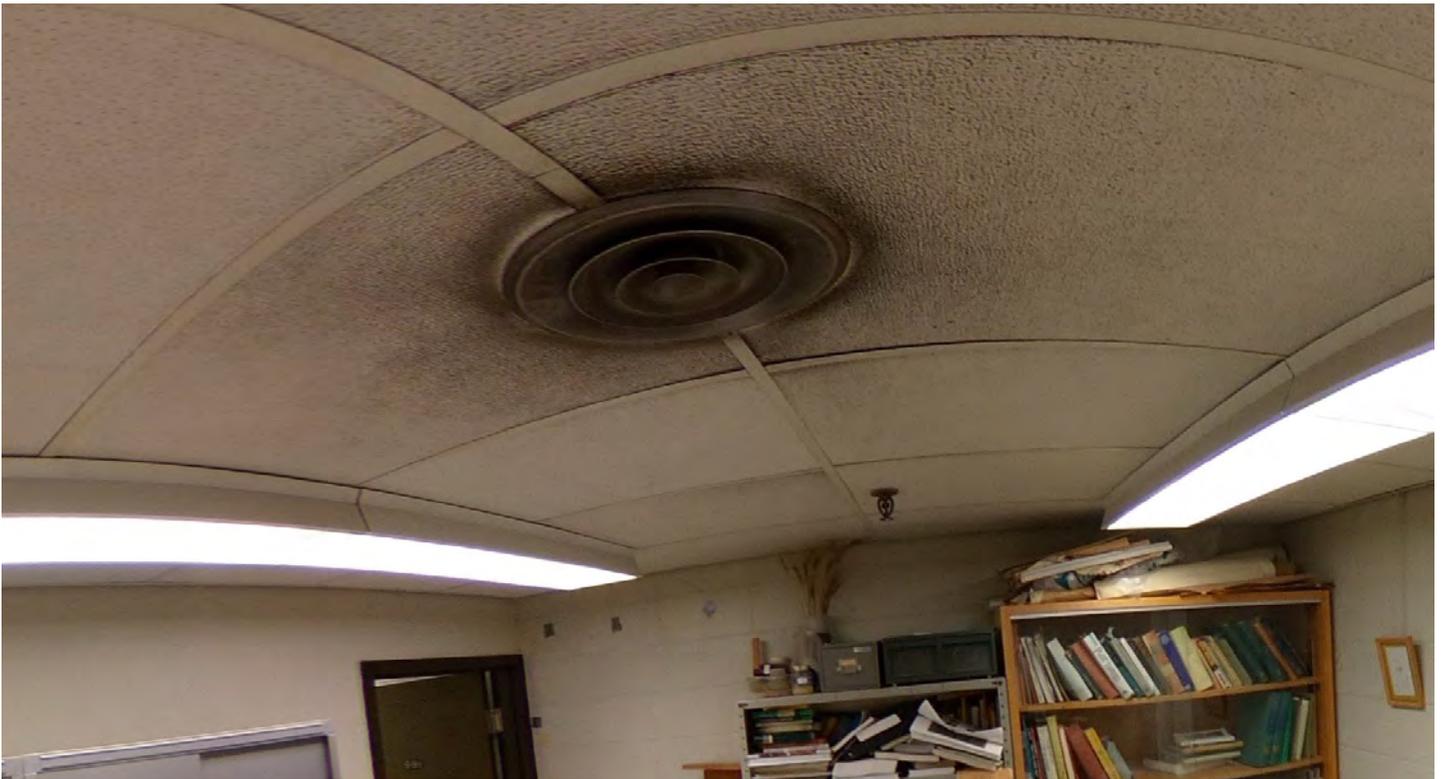
^  
Sediment staining on existing ceiling tiles

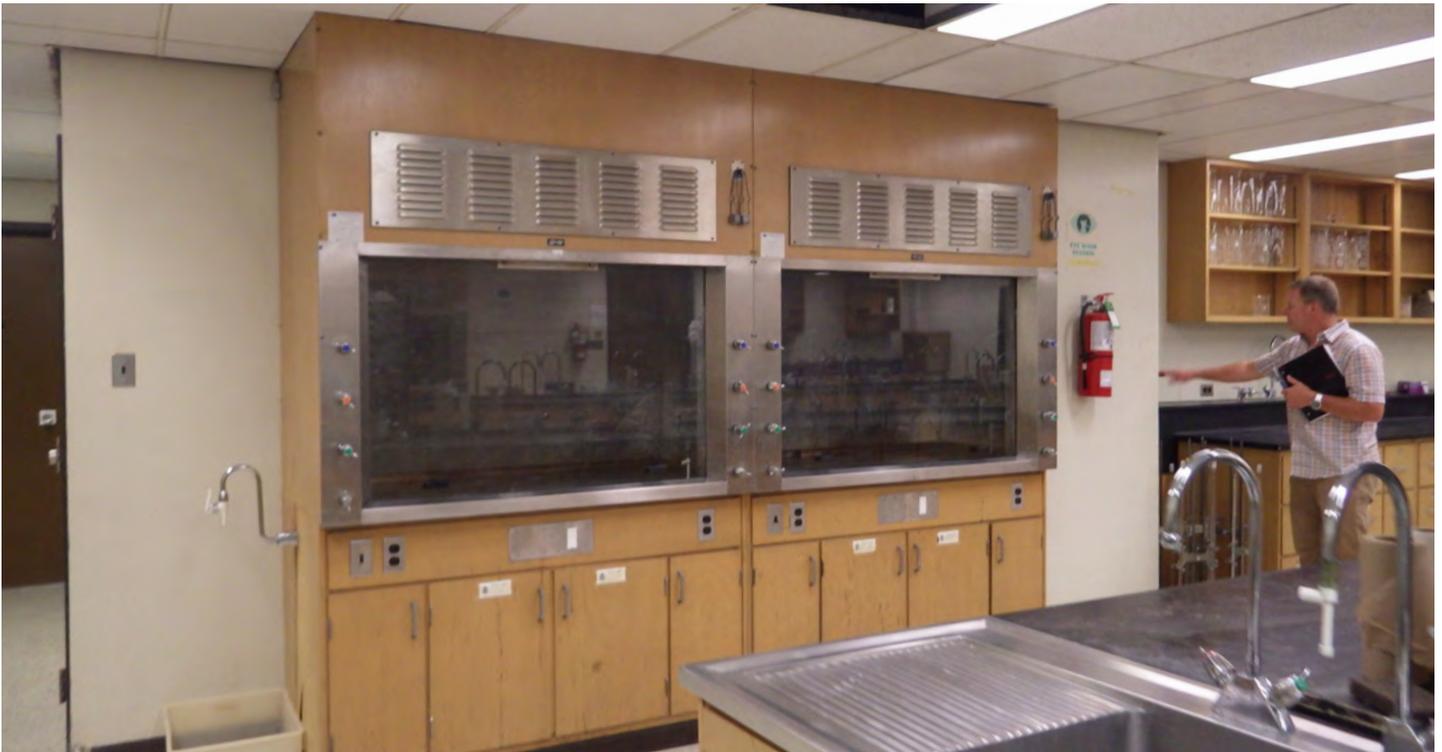
^  
Fume hoods original to the building

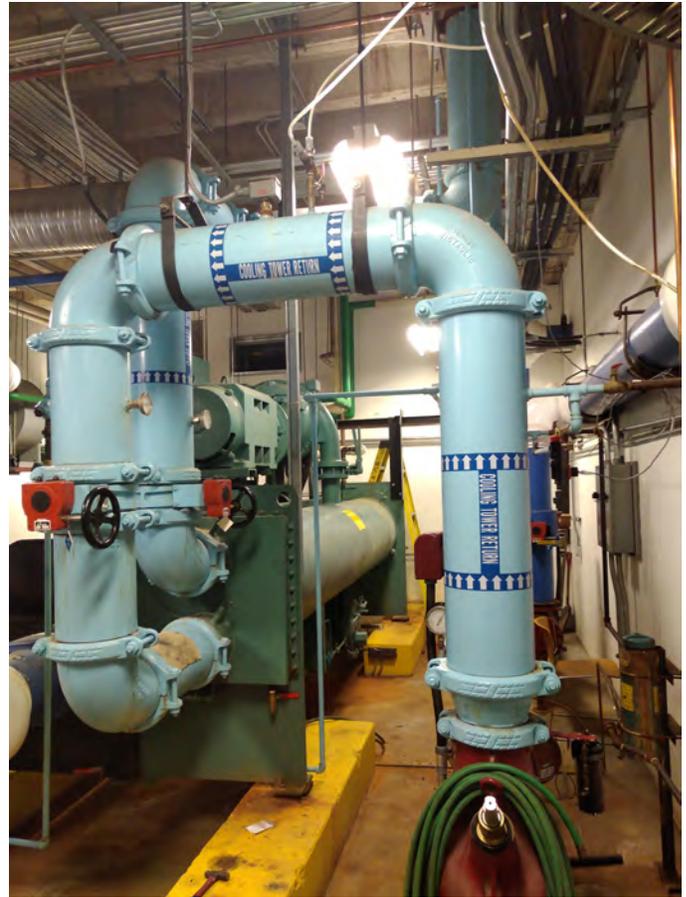
^  
Chiller located in 5th Floor Penthouse Mechanical Room

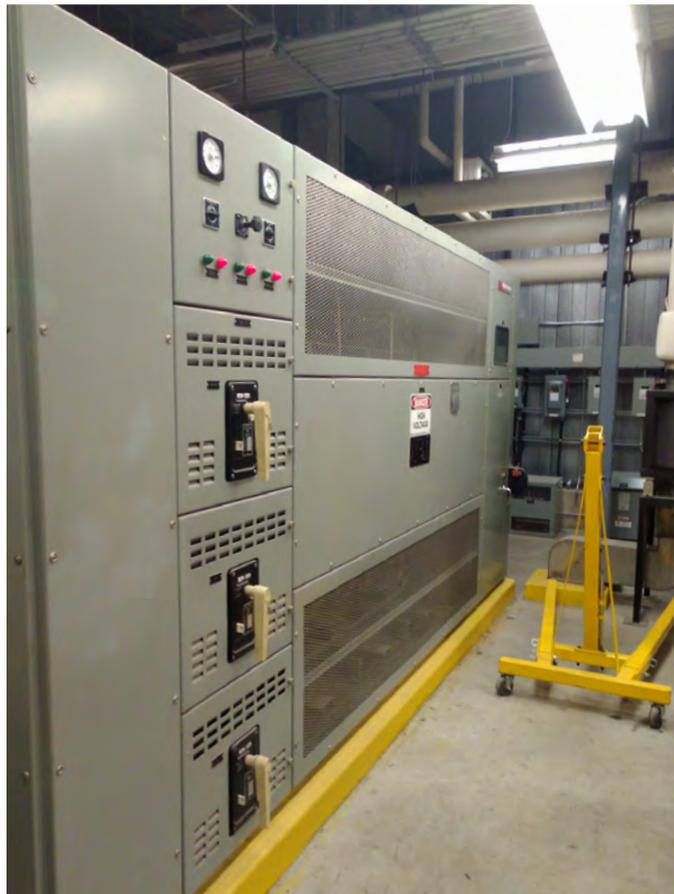
^  
600V Main Distribution A

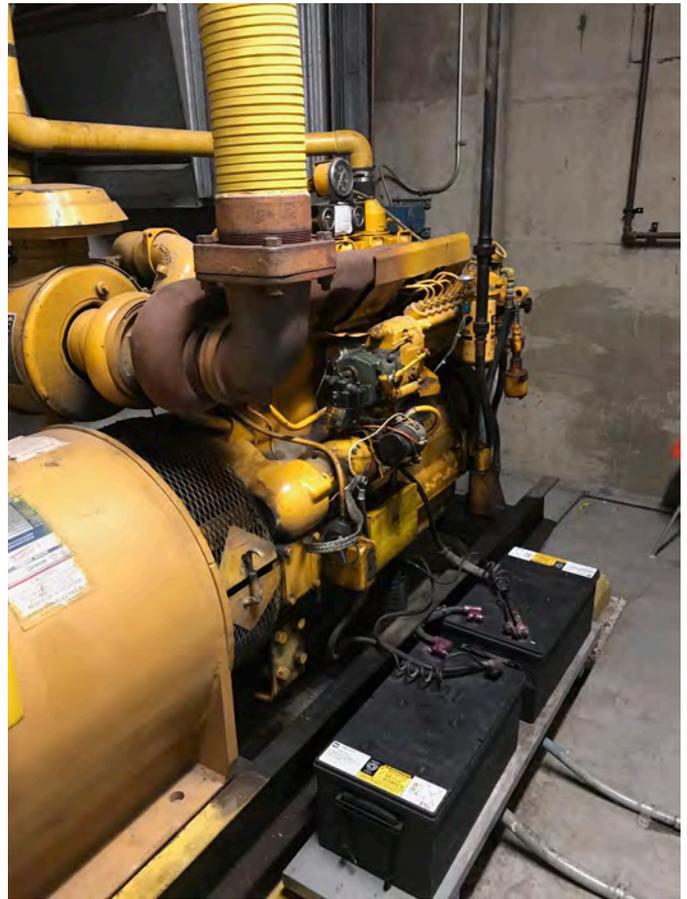
^  
Diesel generator

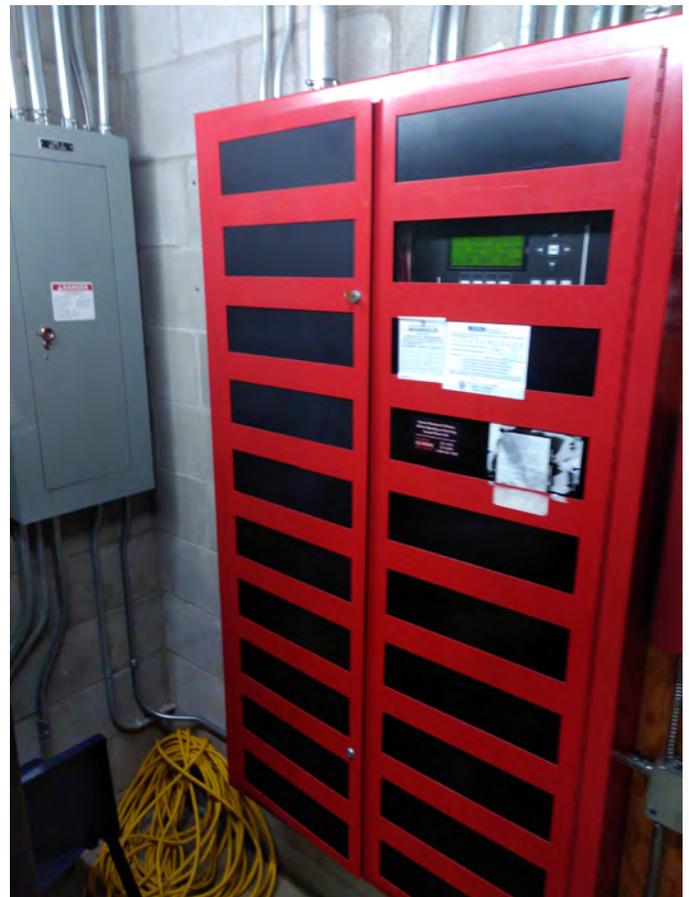
The fire alarm system appears to be in acceptable condition. It was reported that the system was replaced in 2006. It is unknown

^  
Fire alarm control panel

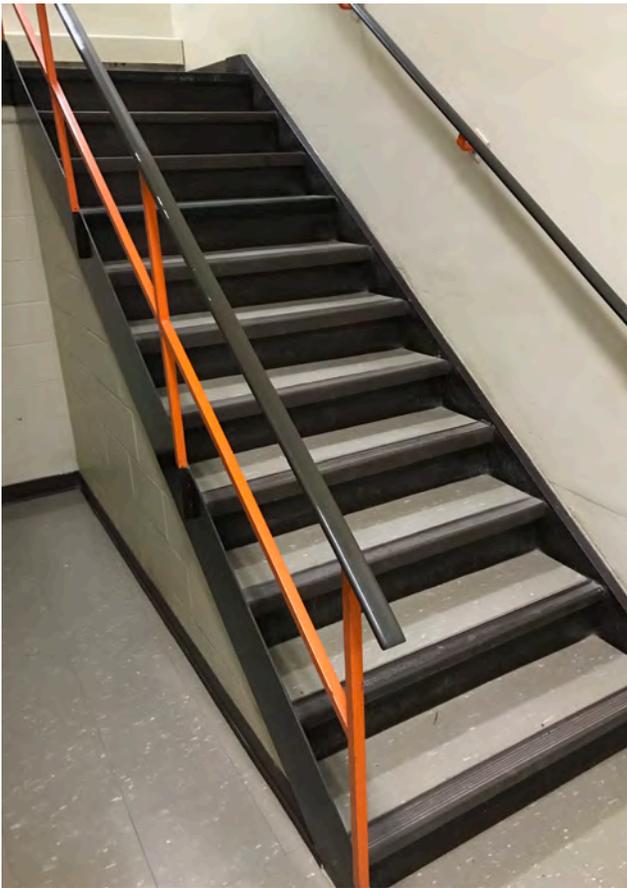
^  
Typical stairwell and non-compliant handrail

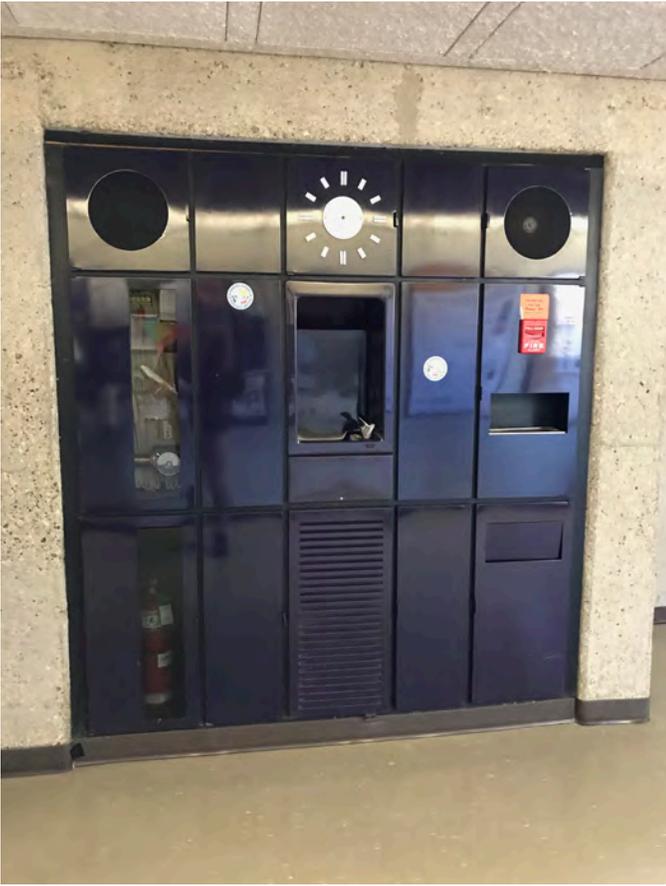
^  
life safety console across from elevator bank that contains a drinking fountain, clock system, alarm pull station, bell and fire extinguisher

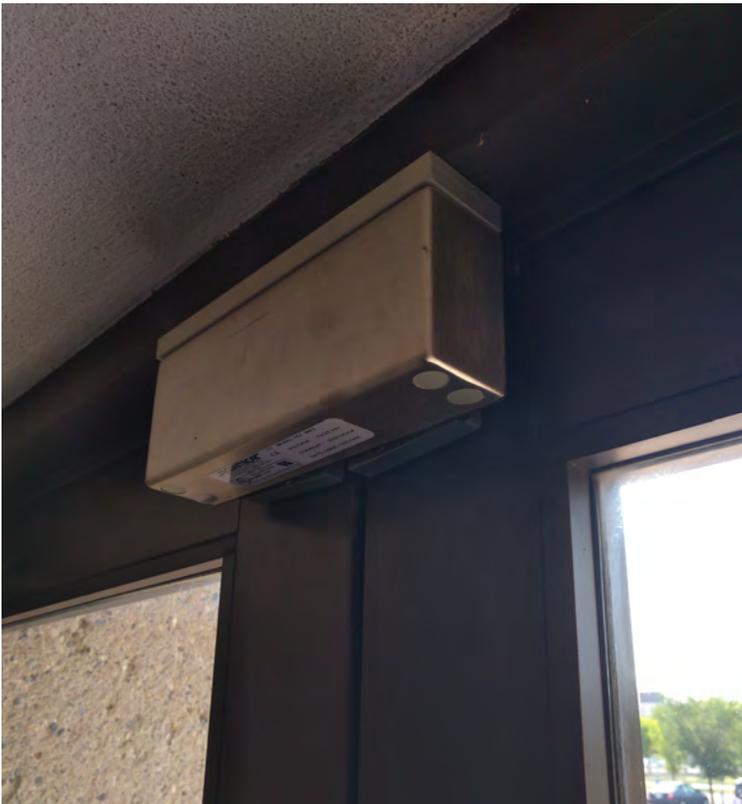
example of magnetic locks located on lower ground and first floor doors that release upon fire alarm signal.

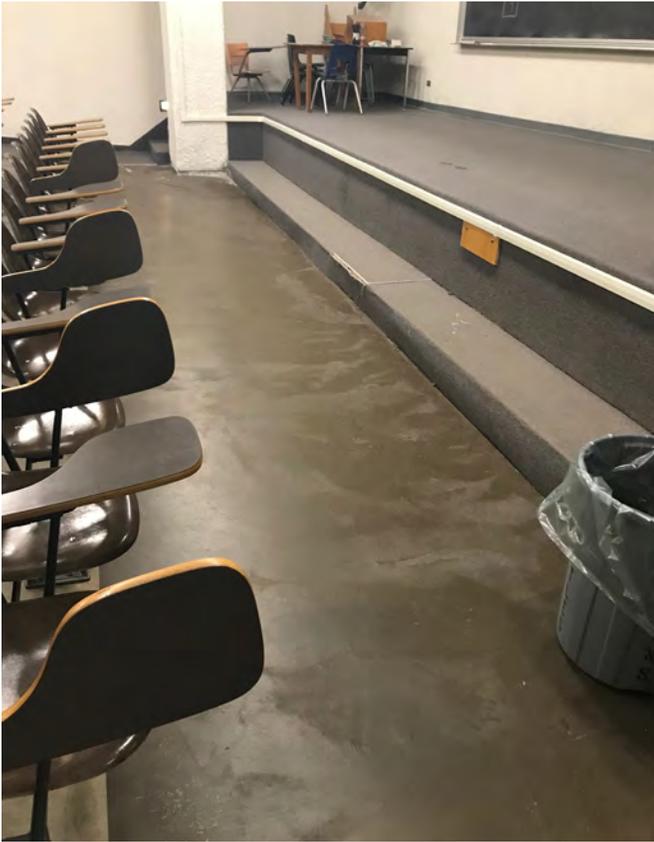
^  
Non-compliant Lecture Theatre stage, with no barrier-free access

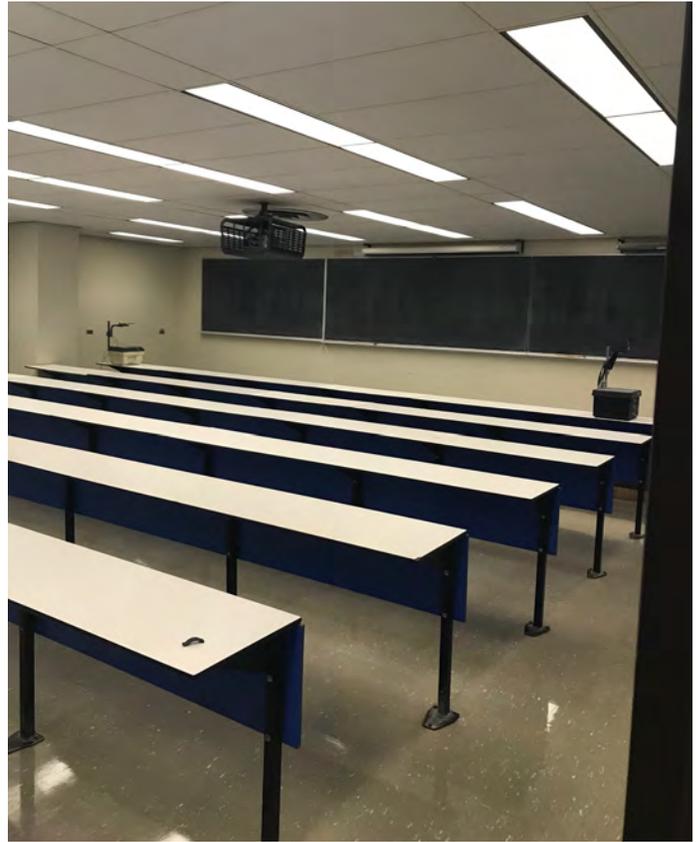
^  
top: fixed classroom tables with minimal clearances, inadequate for barrier-free access; bottom: fixed Lecture Theatre seating, with flip-down writing surfaces that do not meet barrier-free requirements

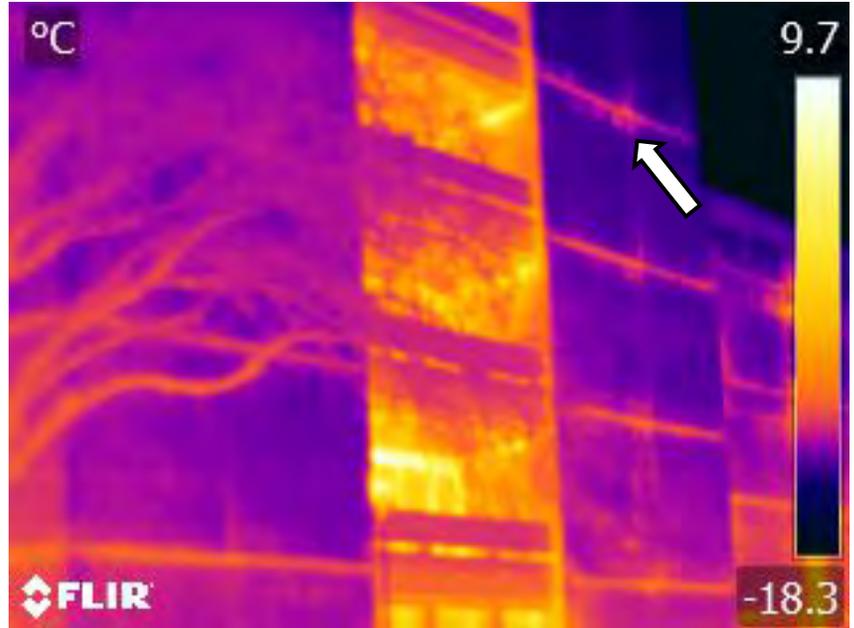
Photograph #10:

Detail view of south elevation.  
Note thermal bridging at shelf  
angles. Also note anomalies  
likely caused by air leakage.

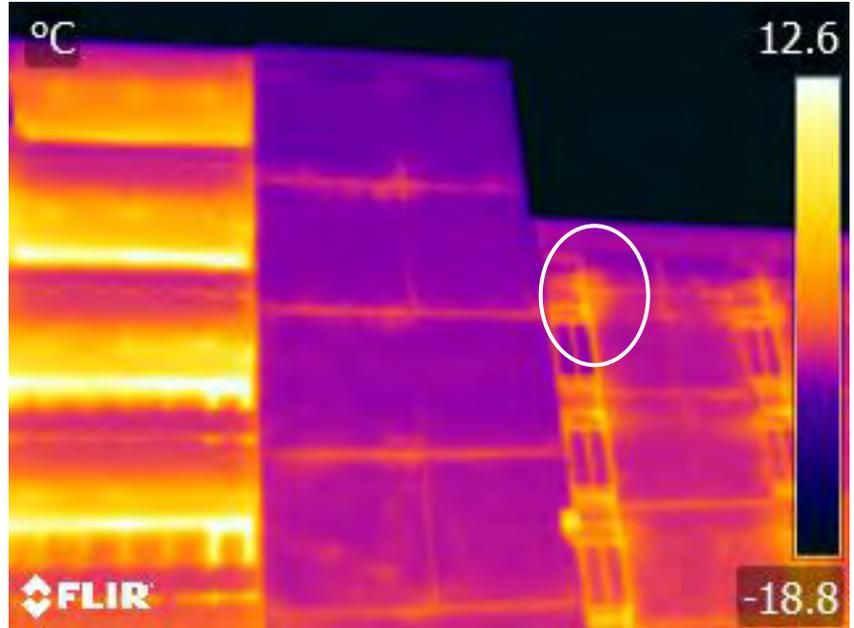
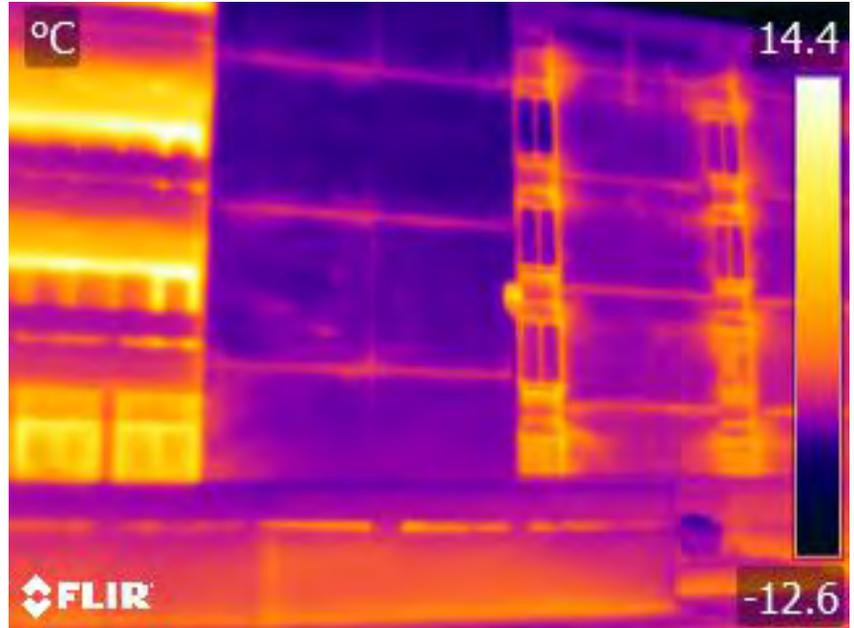
Upper portion of south elevation. Note thermal bridging at shelf angle/floor slab locations. Also note apparent air leakage at window corners.

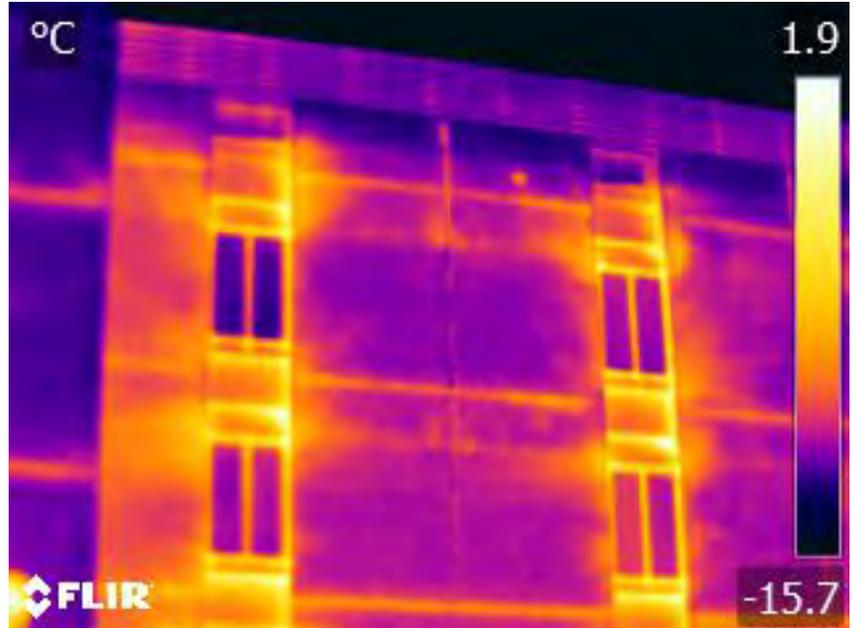
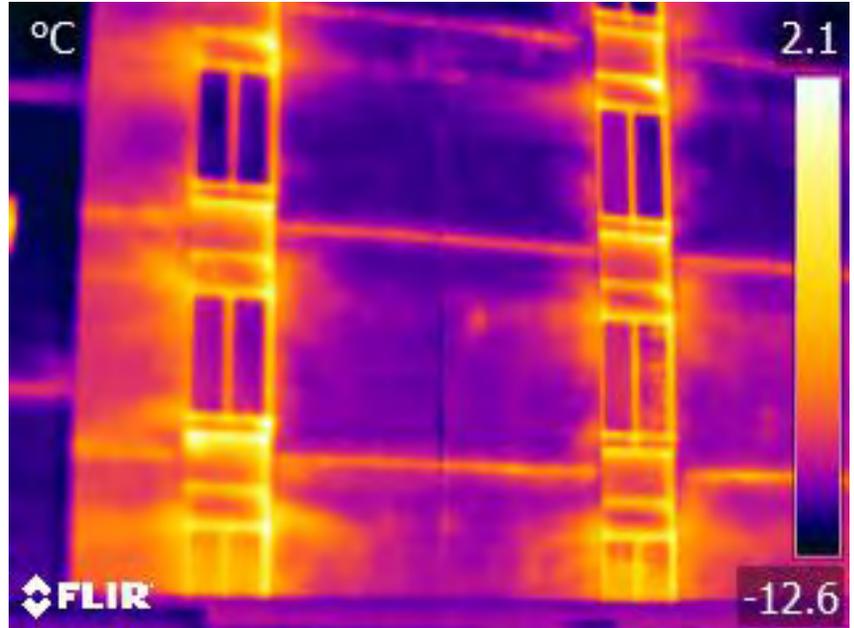
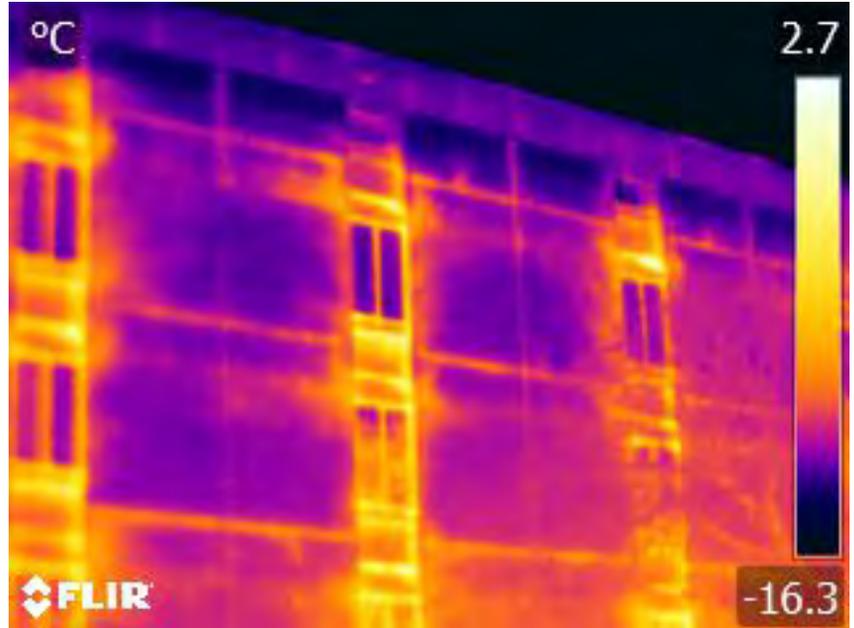
Detail view of south elevation showing thermal bridging at floor slab locations. Also note apparent air leakage at window jamb locations.

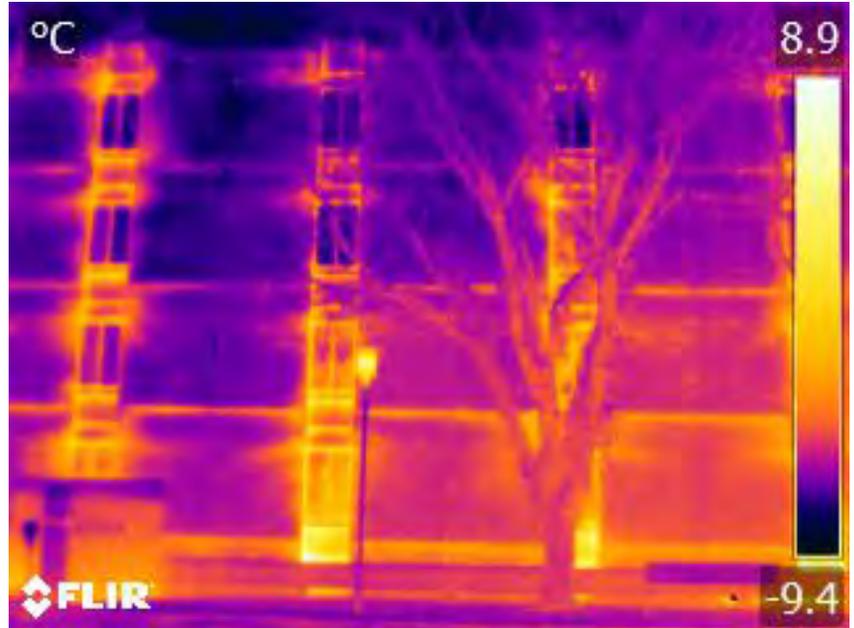
Photograph #48:

Partial south elevation. Note  
apparent air leakage at most  
windows.

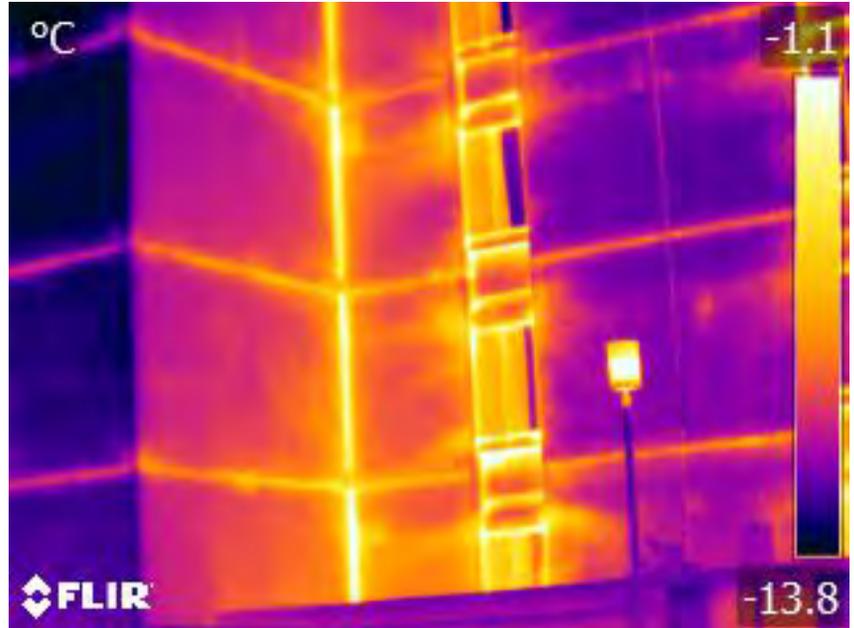
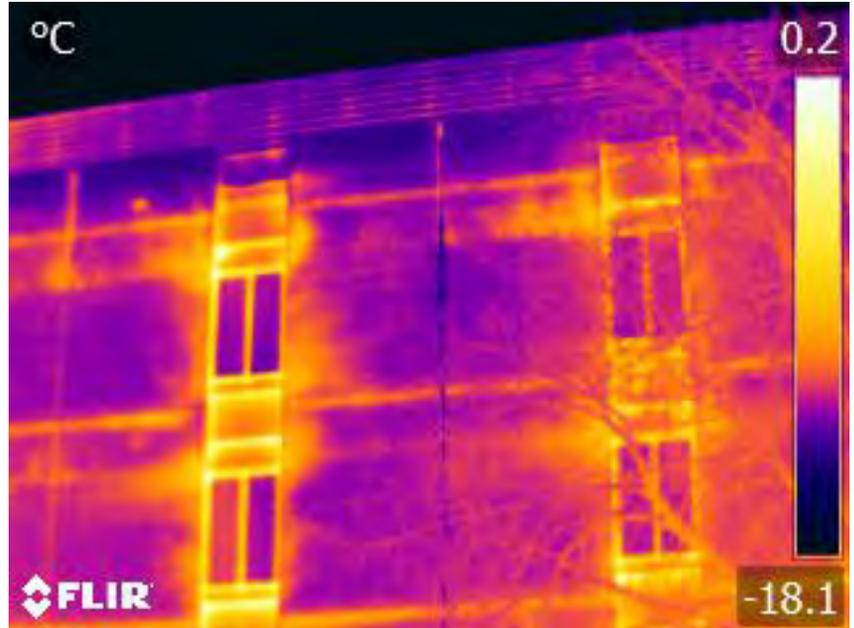
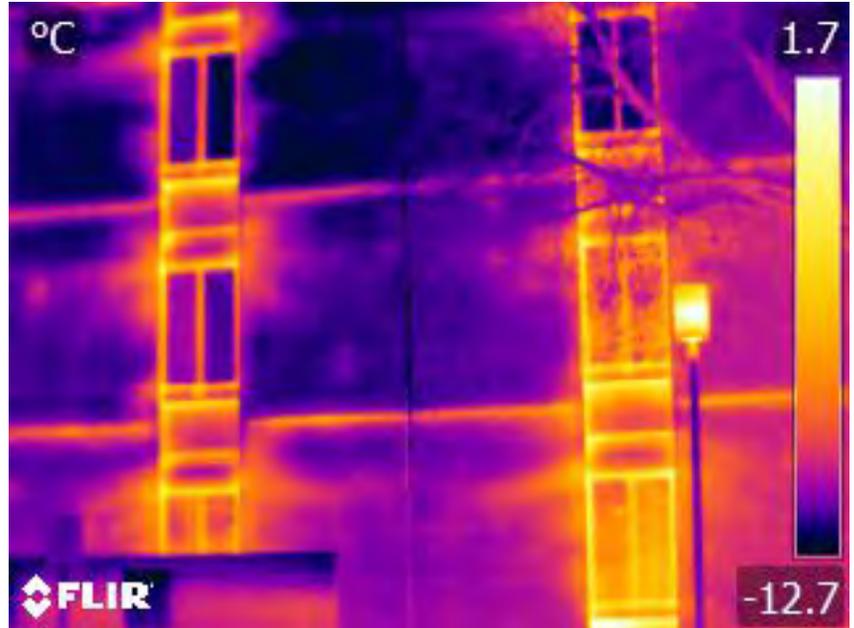
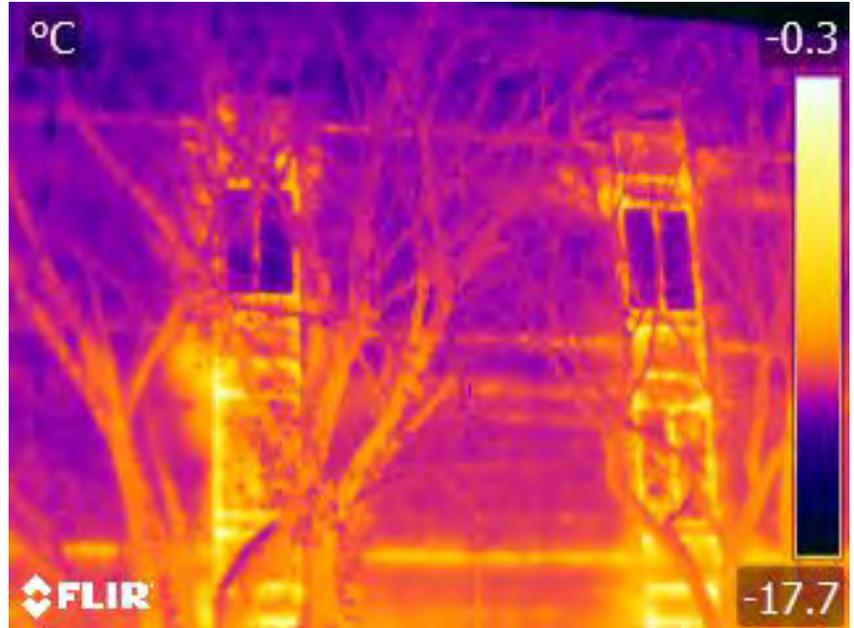
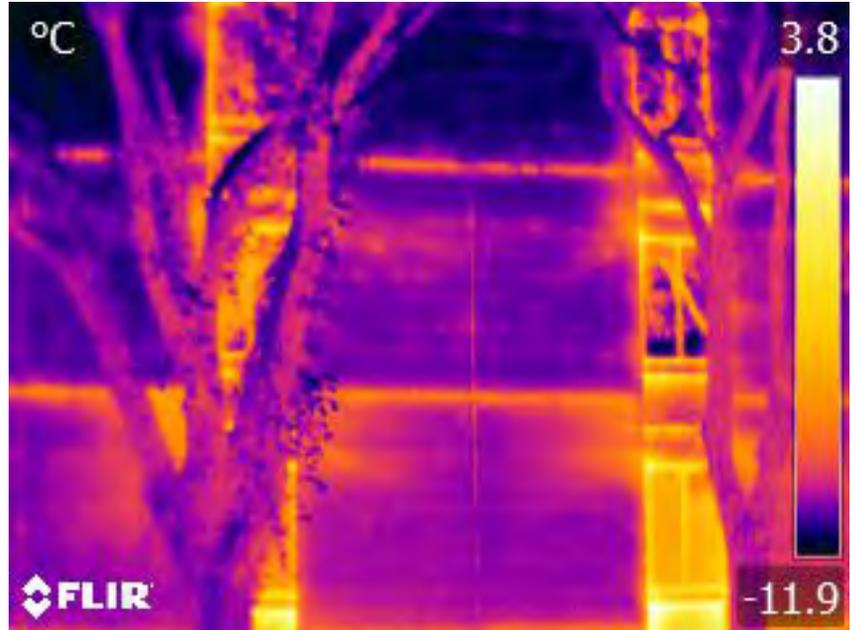
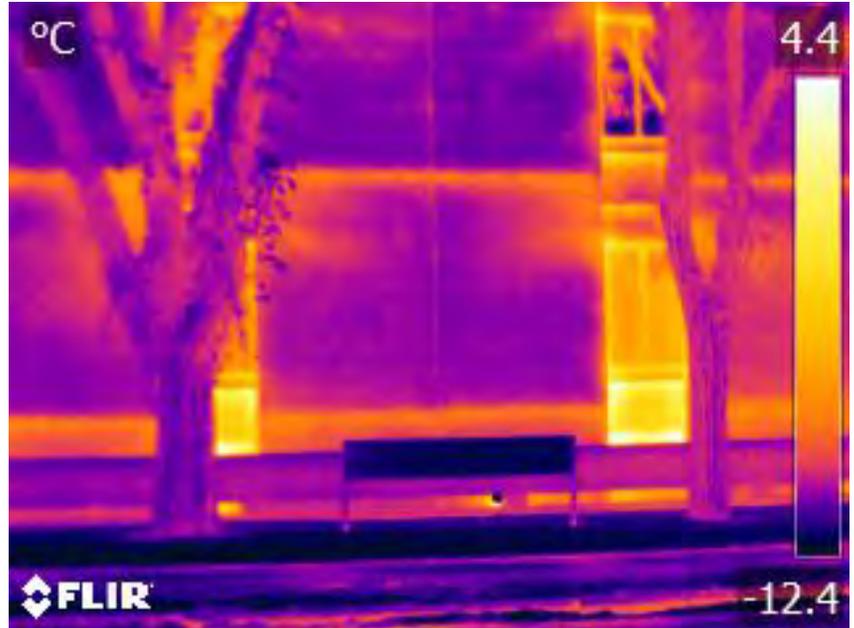
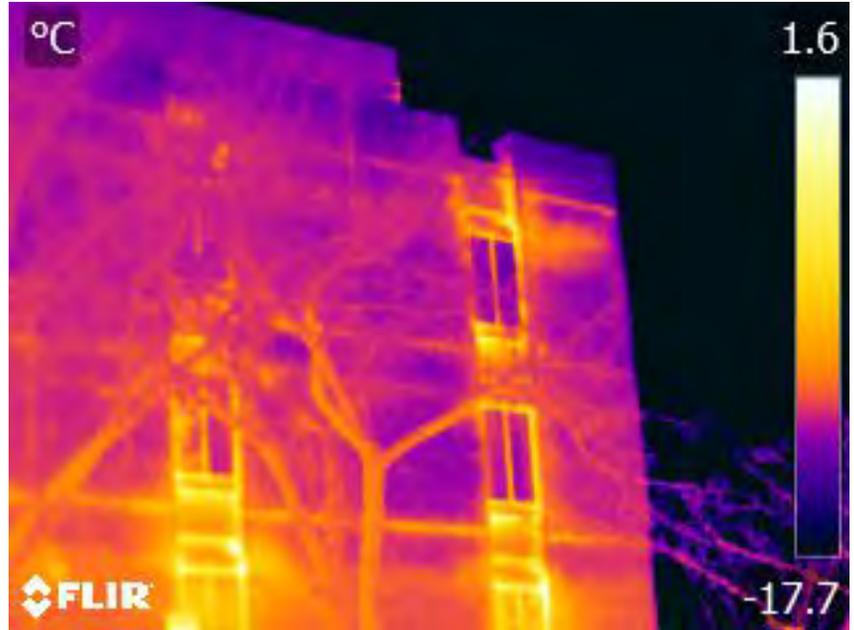
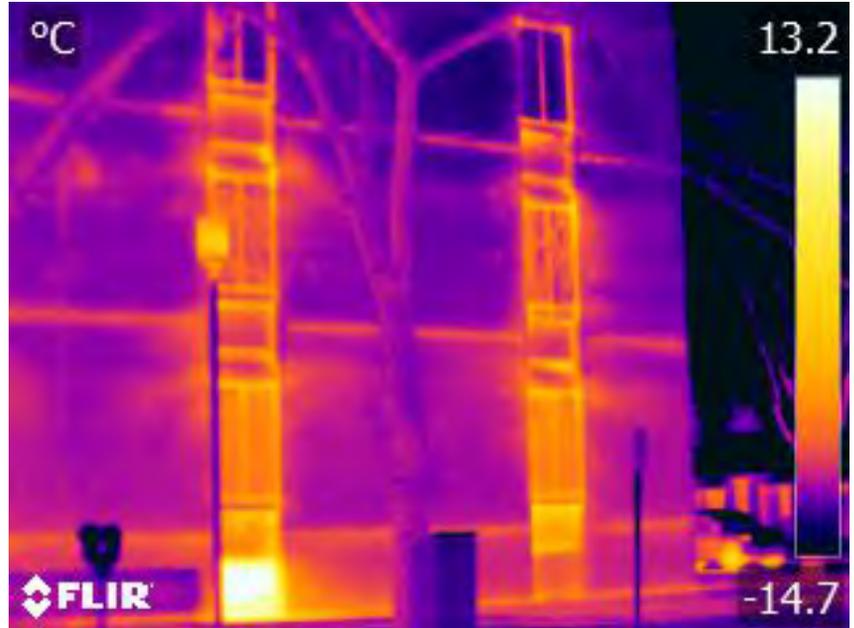
Detail view of south elevation near entrance. Note thermal bridging a floor slabs as well as air leakage at windows.

Detail view of south elevation.  
Note thermal bridging a floor  
slabs as well as air leakage at  
windows.

Detail view of east end of south elevation. Note thermal bridging a floor slabs as well as air leakage at windows.

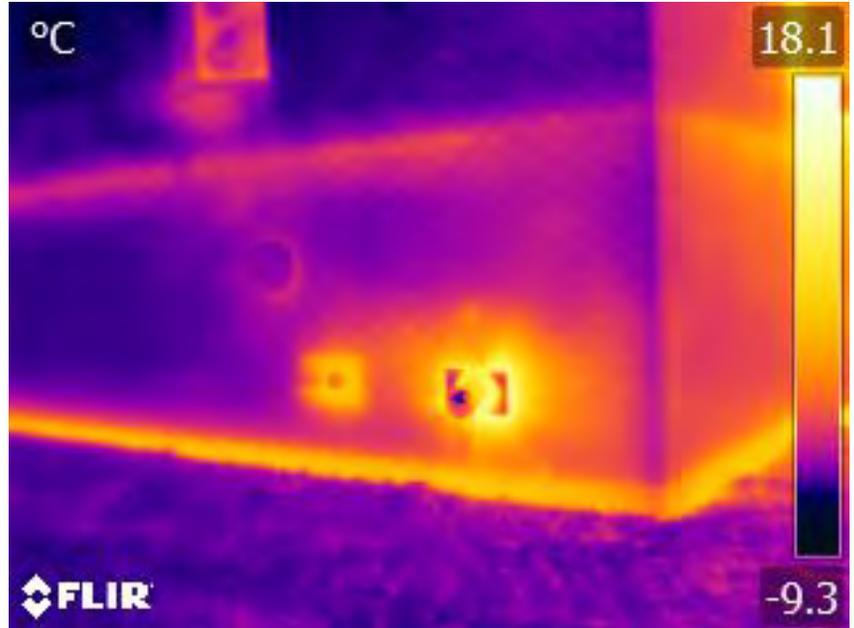
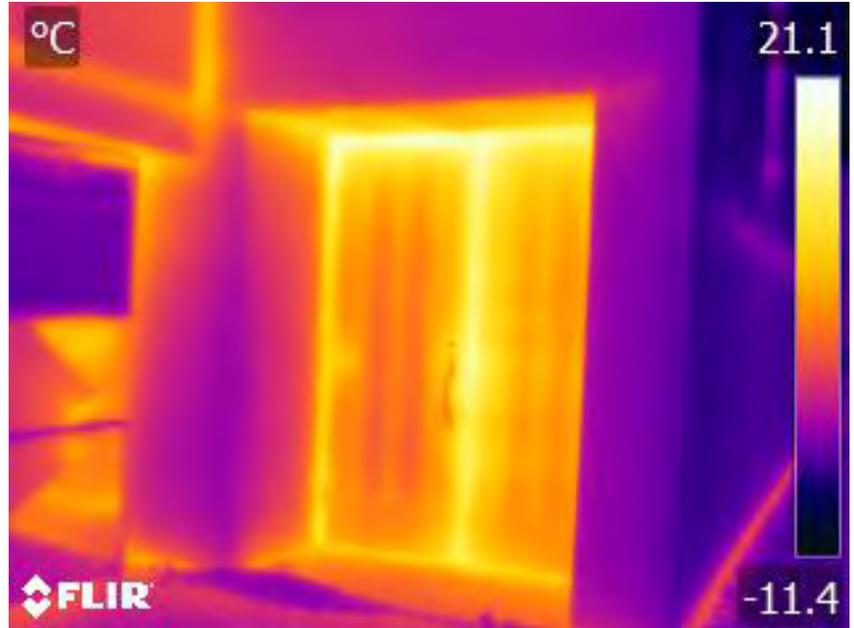
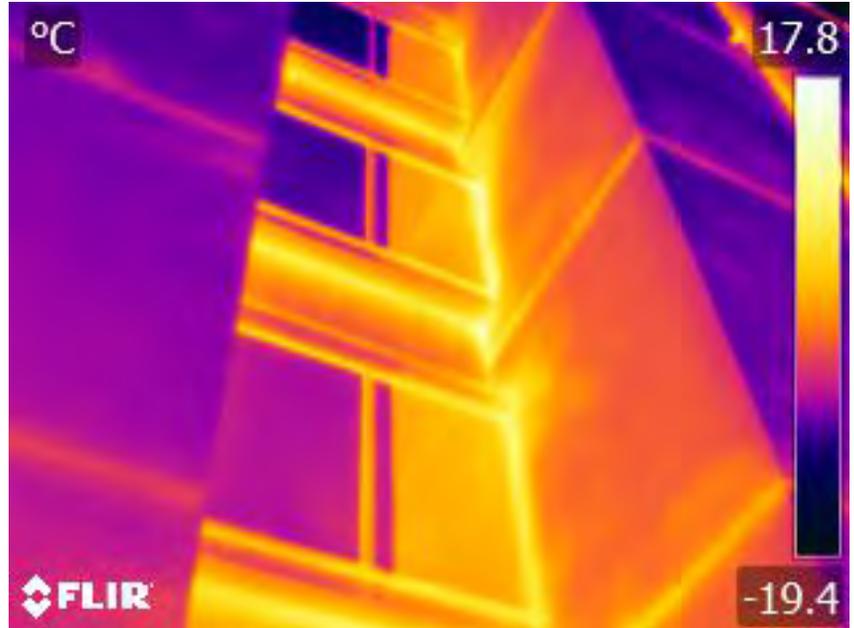
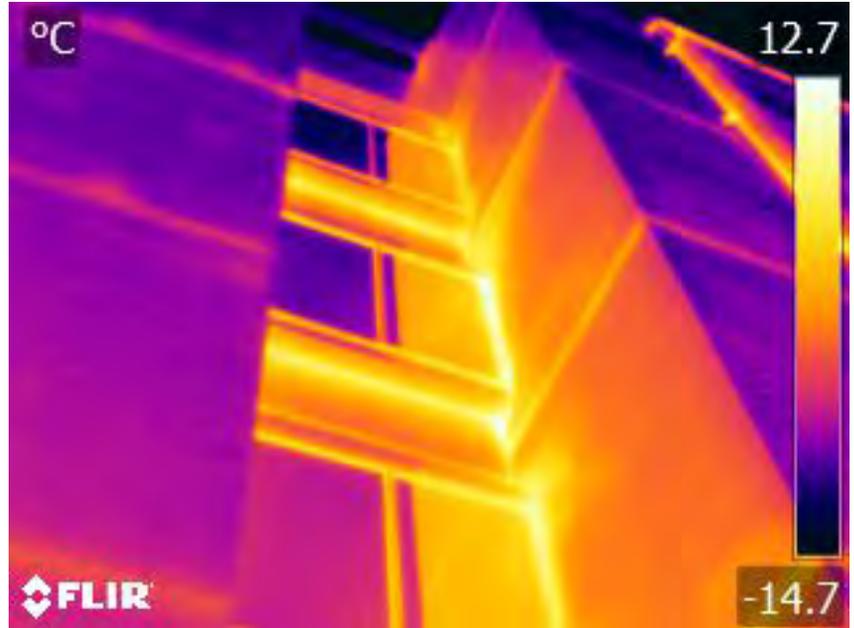
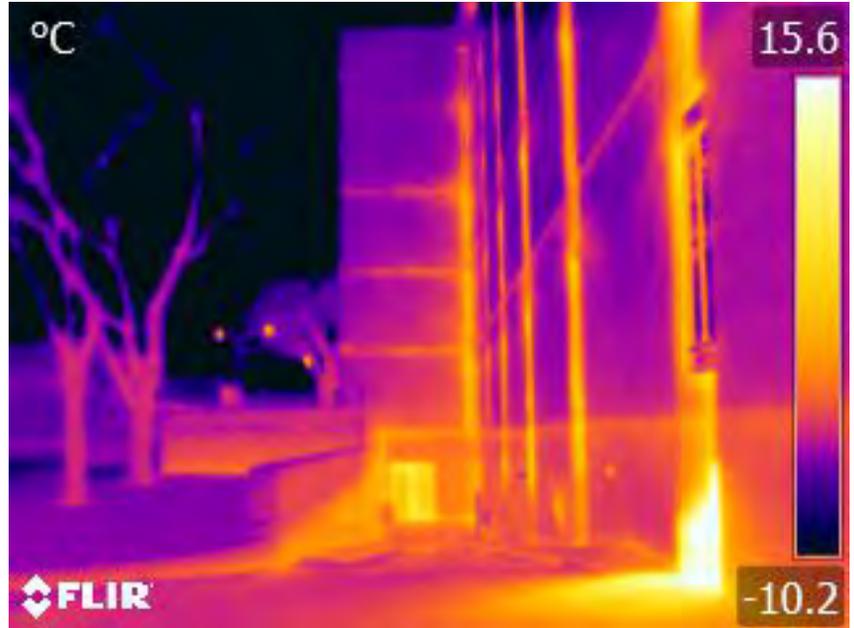
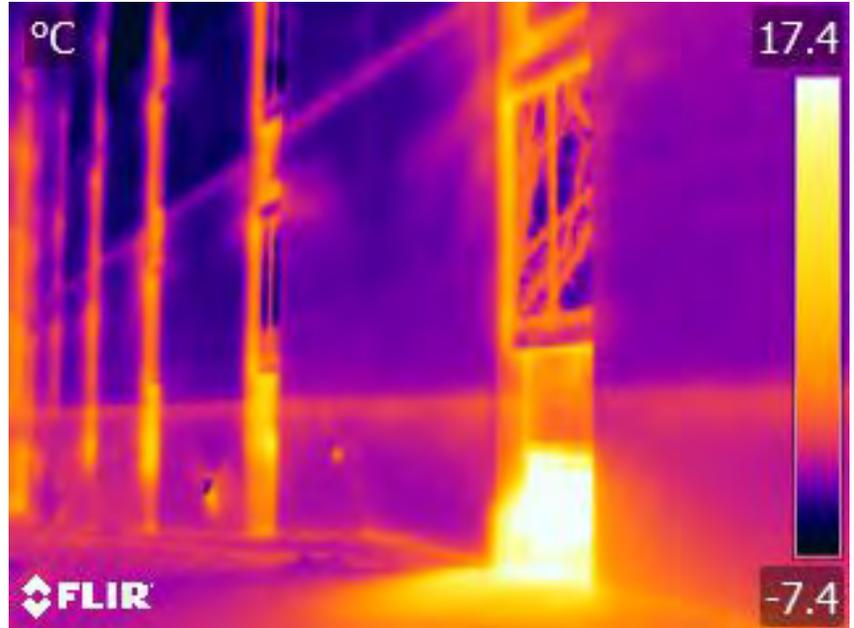
Detail view of south elevation.  
Note thermal anomalies caused  
by air leakage at mechanical  
penetration and thermal  
bridging at masonry support  
and foundation wall.

Detail view of south elevation.  
Note thermal anomalies caused  
by air leakage and thermal  
bridging.

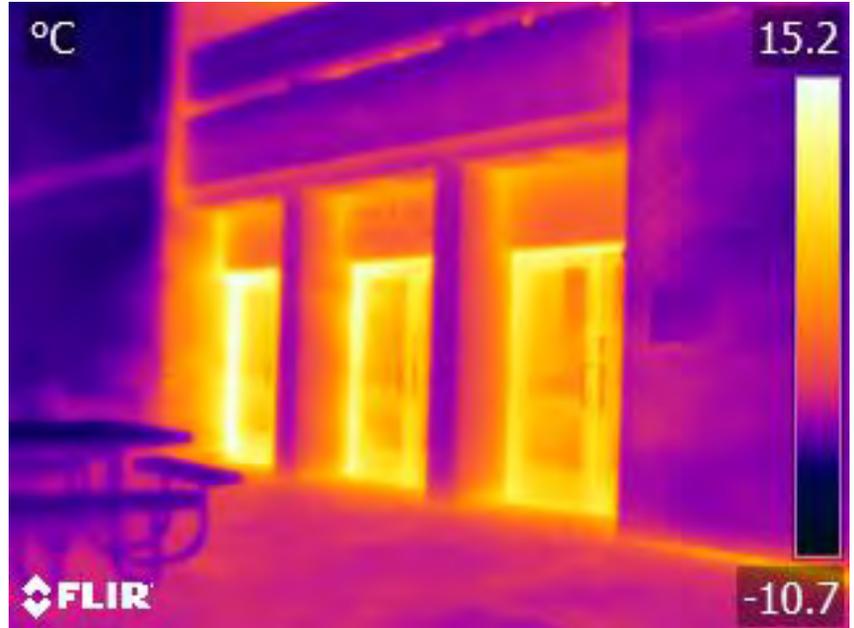
Photograph #84:

Detail view of south entrance doors. Note anomalies caused by air leakage and thermal bridging.
