**BRANDON  
UNIVERSITY**

**John R. Brodie Science Centre**  
Preliminary Assessment & Conceptual Design Recommendations  
for Brandon University

February 2019

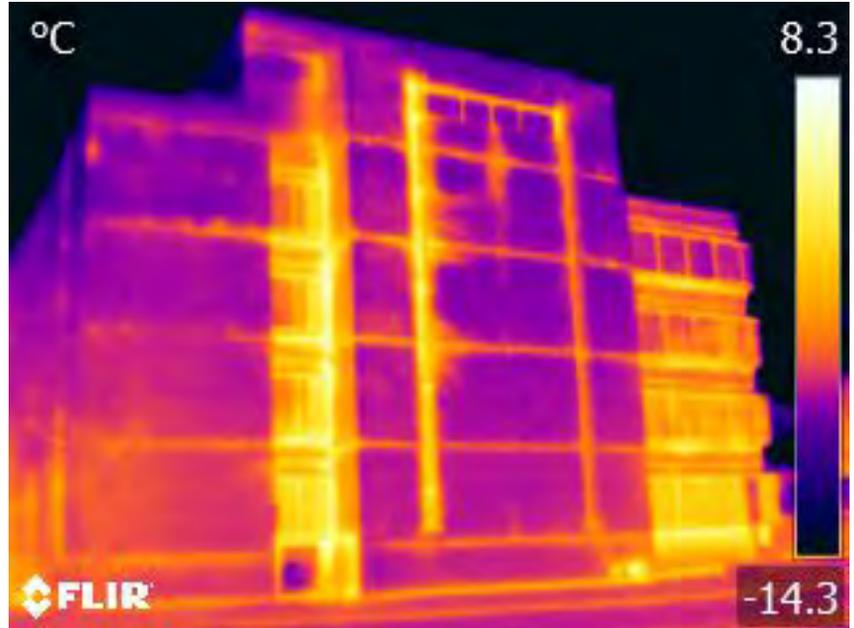
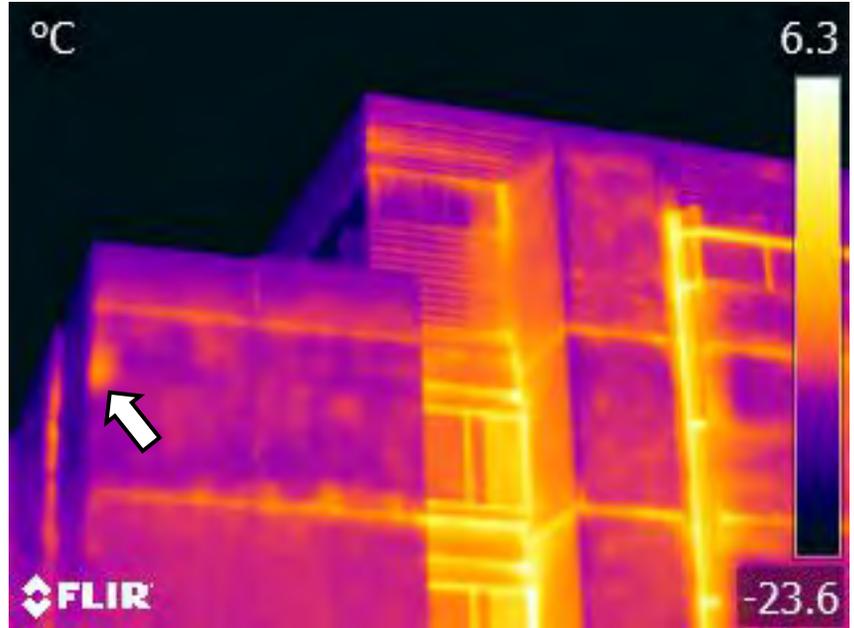
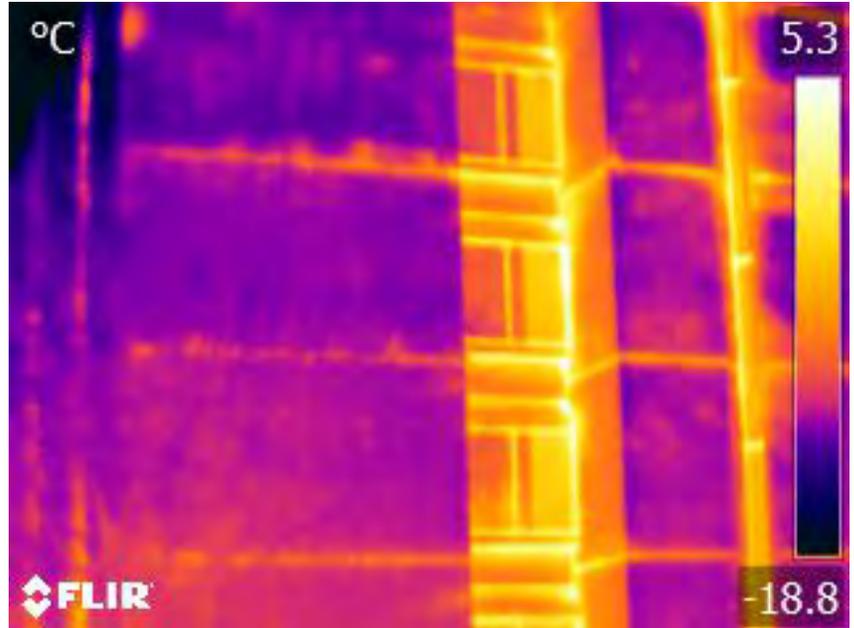
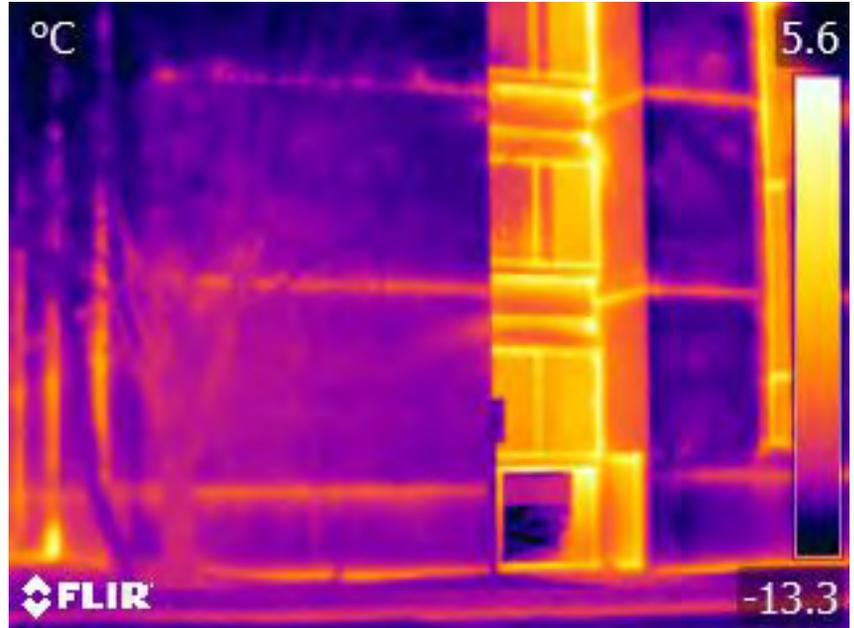
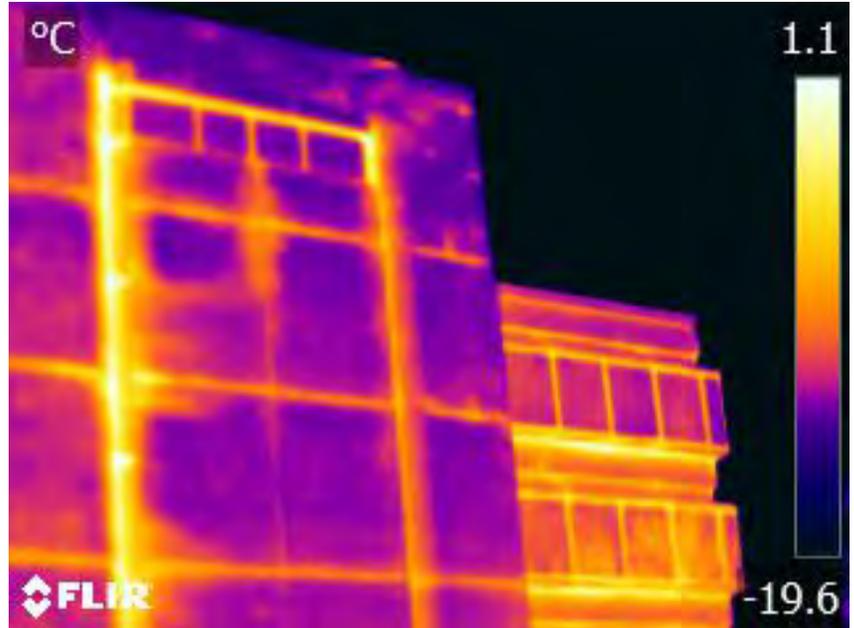
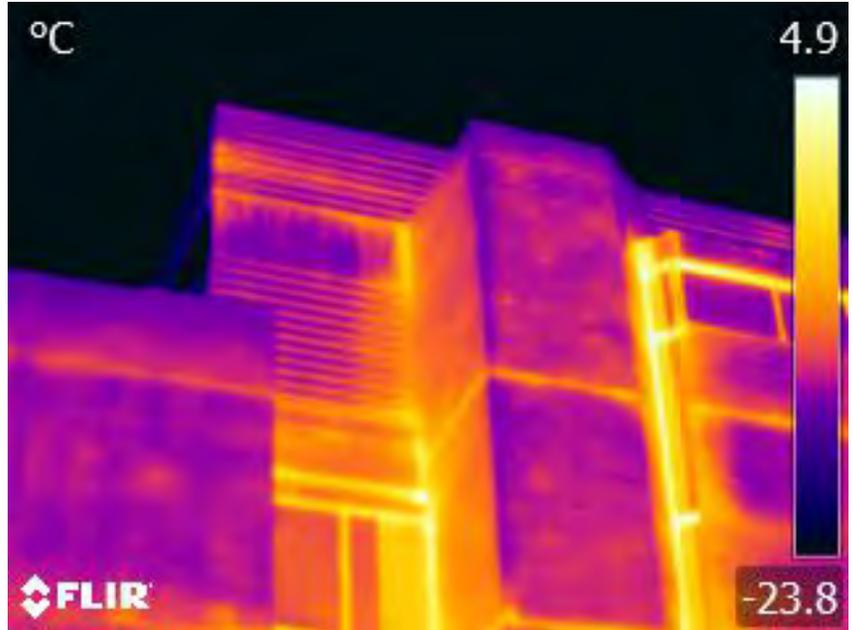
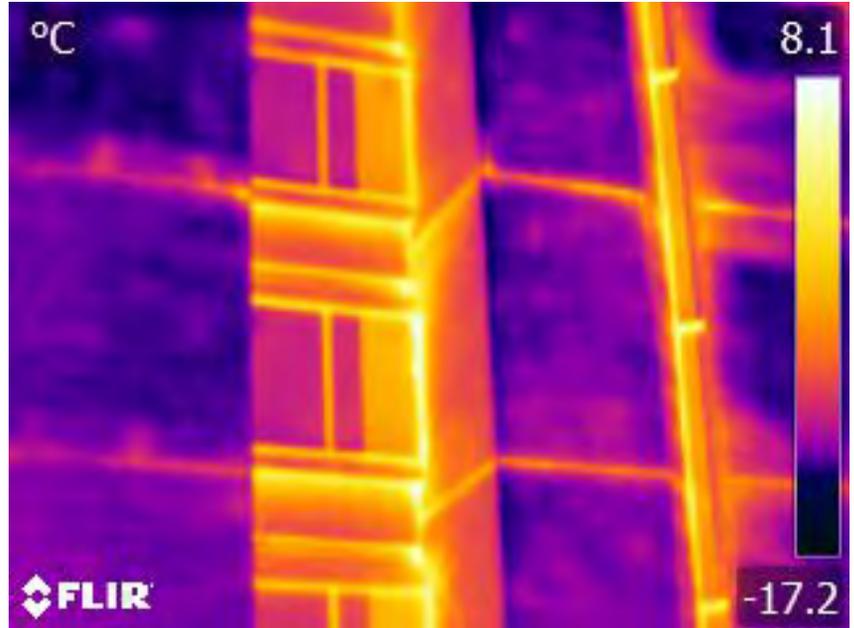
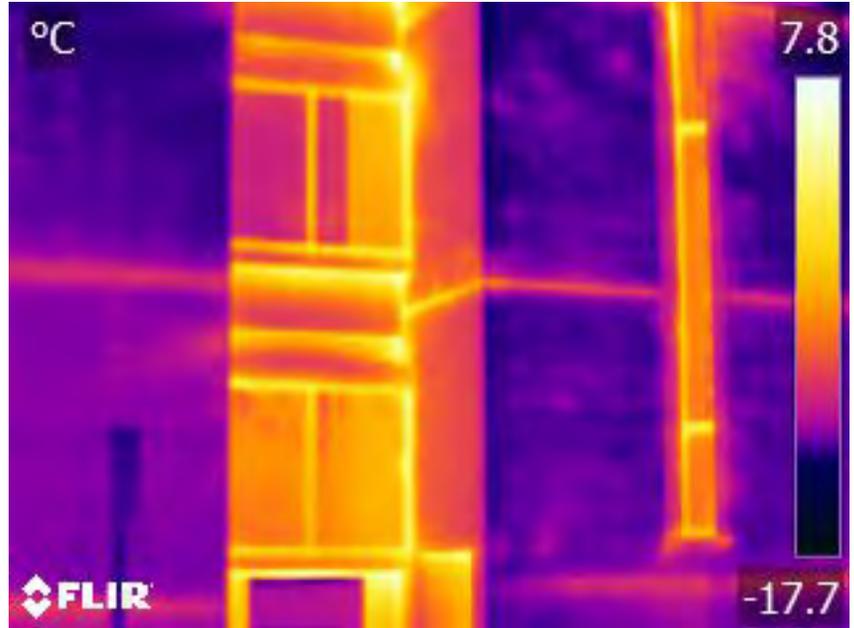
Overall east elevation showing thermal anomalies caused by air leakage and thermal bridging.

Detail view of upper portion of east elevation. Note thermal anomalies in opaque wall areas likely caused by discrete air leakage.

Detail view of upper portion of east elevation. Note thermal anomalies caused by air leakage and thermal bridging.

Detail view of east elevation.  
Note thermal anomalies caused  
by air leakage and thermal  
bridging.

Detail view of east elevation near grade. Note thermal anomalies caused by air leakage and thermal bridging.

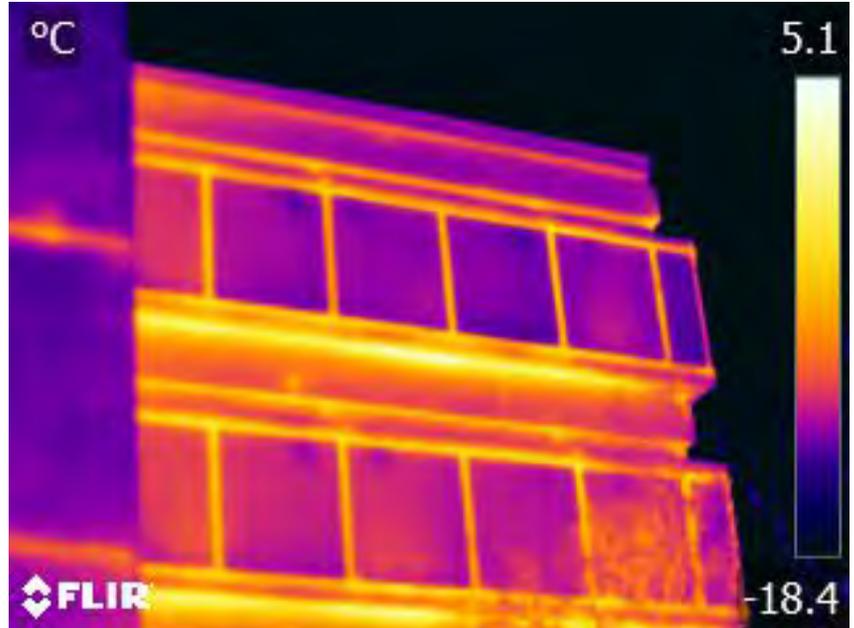
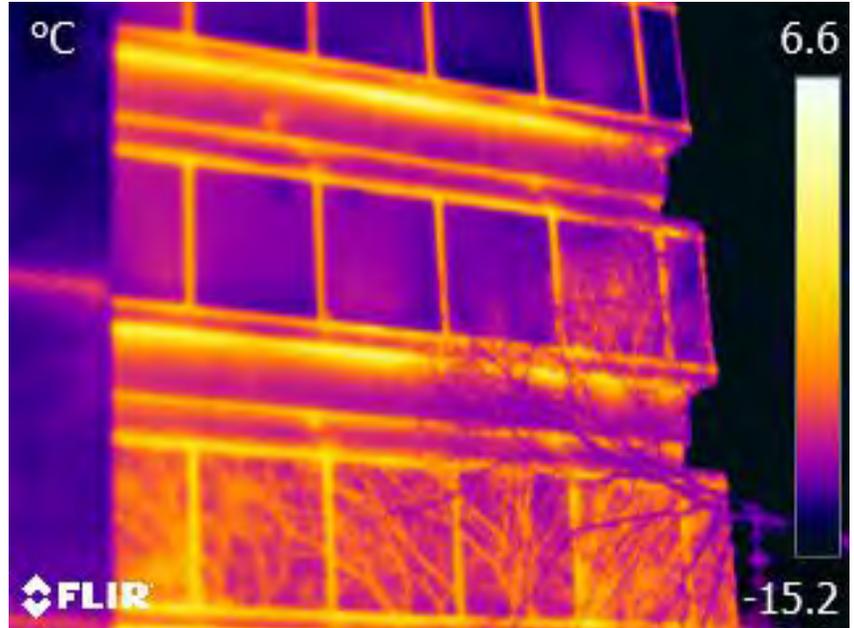
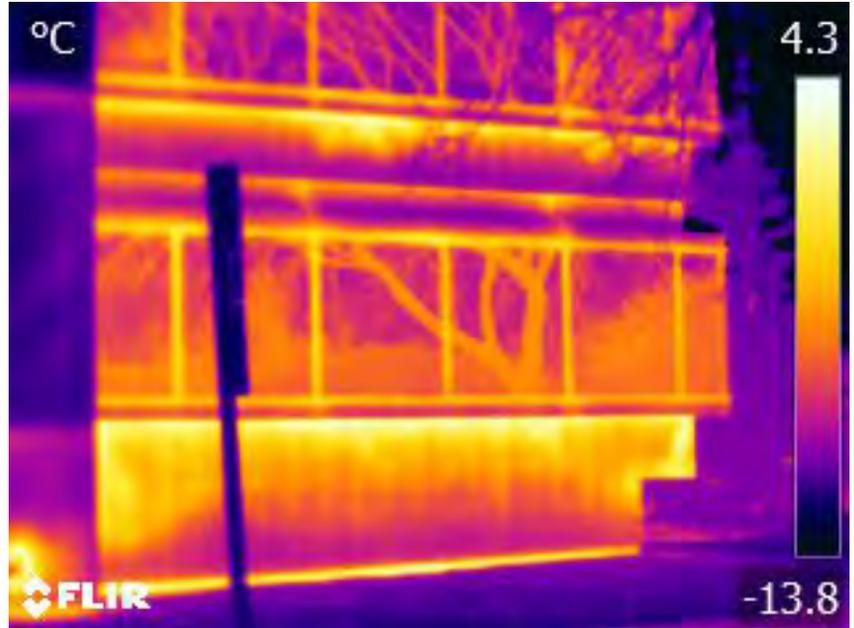
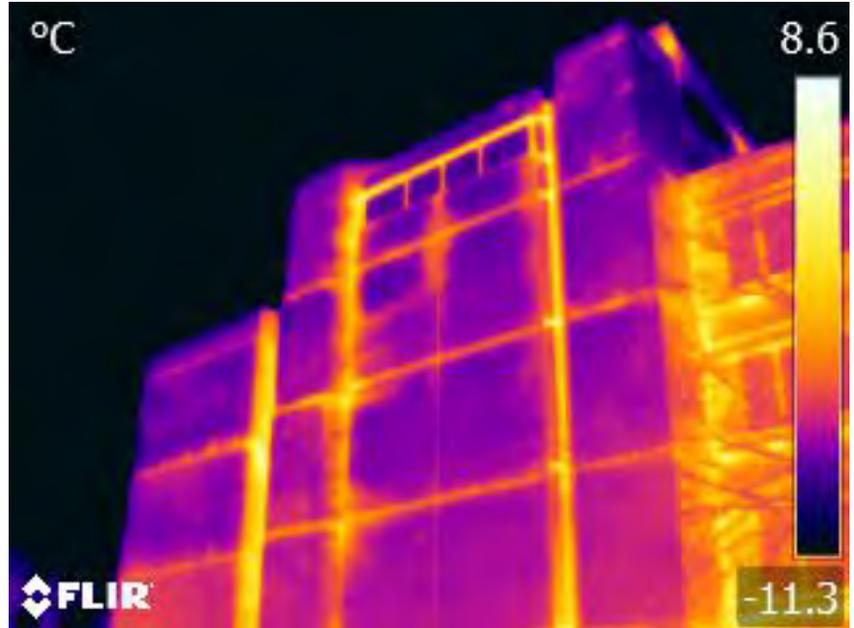
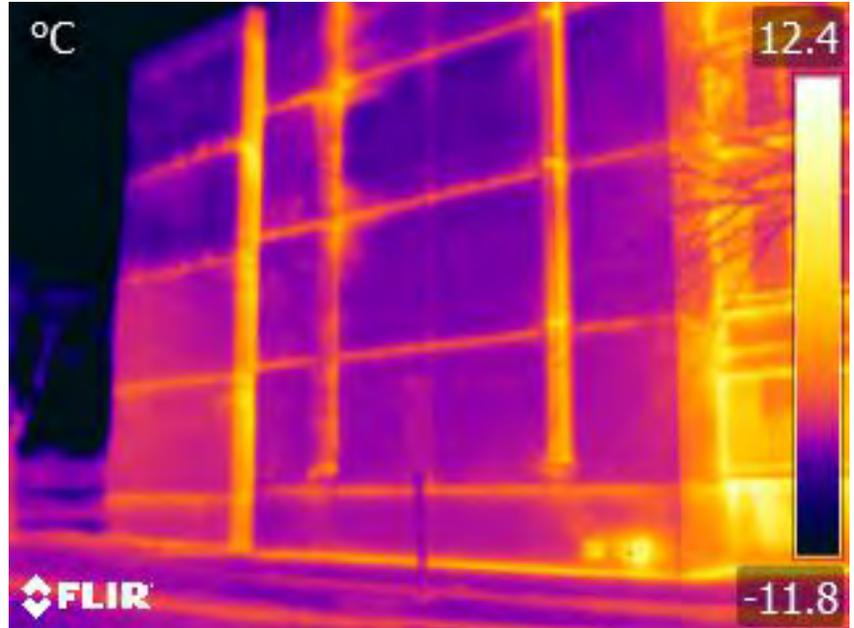
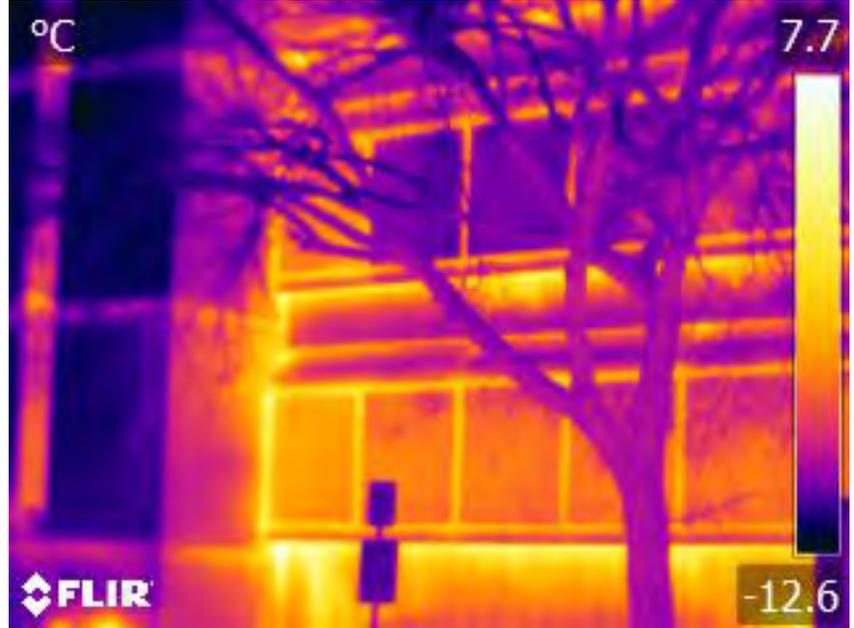
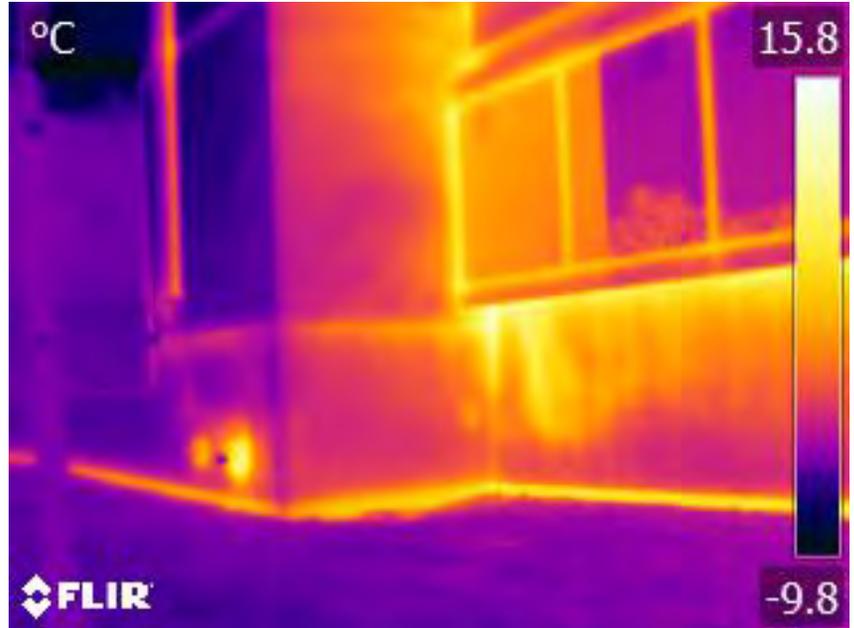
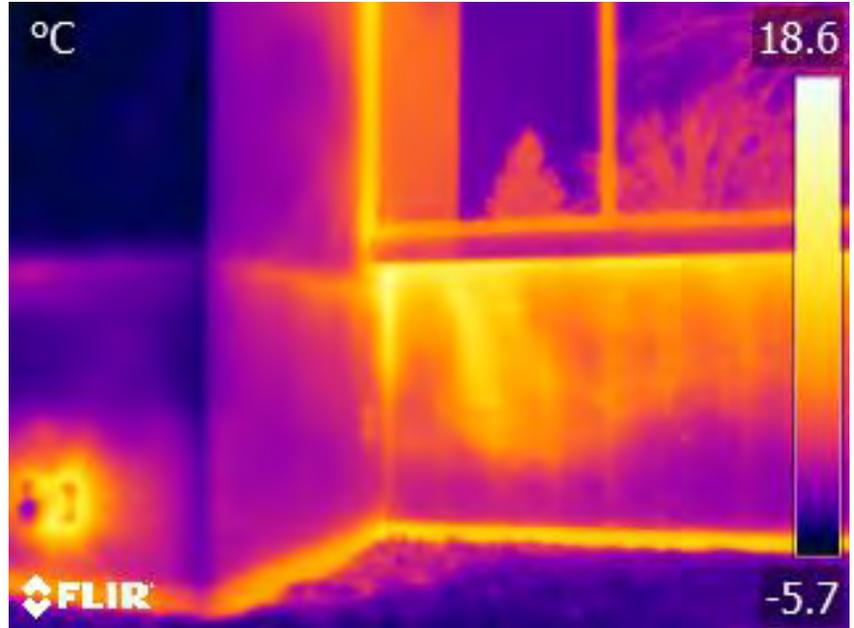
Detail view of upper portion of east elevation. Note thermal anomalies caused by air leakage at window framing.

Detail view of east elevation.  
Note thermal anomalies caused  
by air leakage at window  
framing.

Detail view of east elevation at grade. Note thermal anomalies caused by air leakage at window framing.

Detail view of east elevation at grade. Note thermal anomalies caused by air leakage around windows.

Detail view of east elevation.  
Note thermal anomalies caused  
by air leakage around and  
below the windows.

Detail view of east elevation.  
Note thermal anomalies caused  
by air leakage at window sill  
and mechanical penetration.

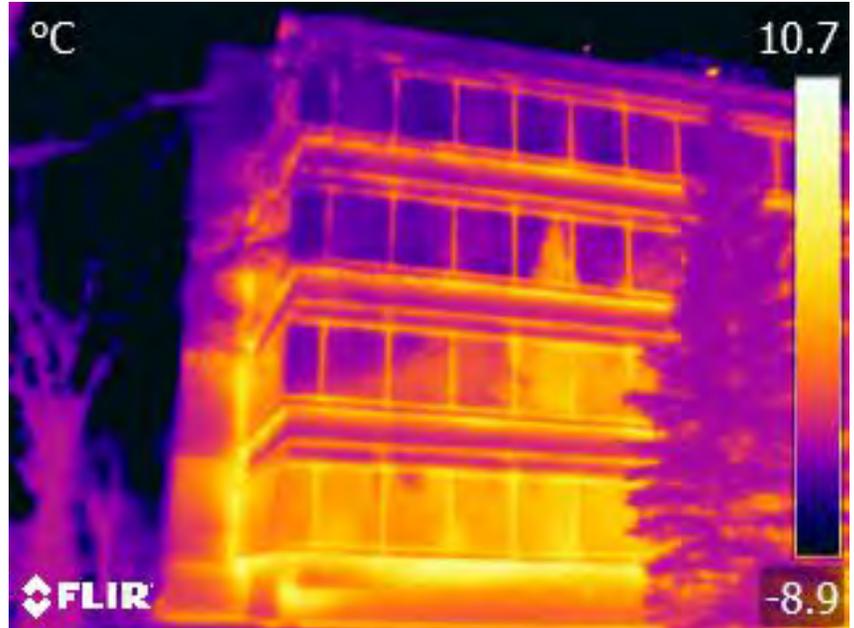
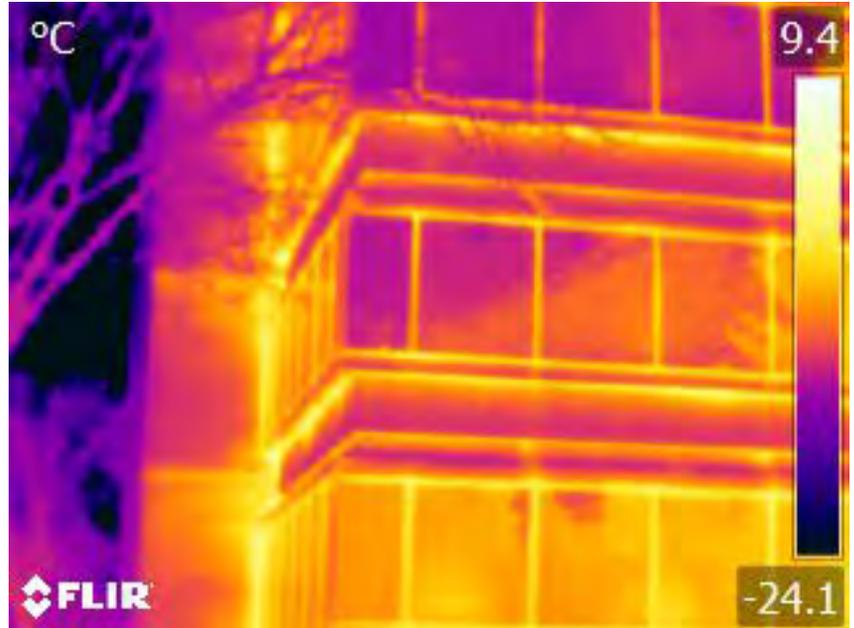
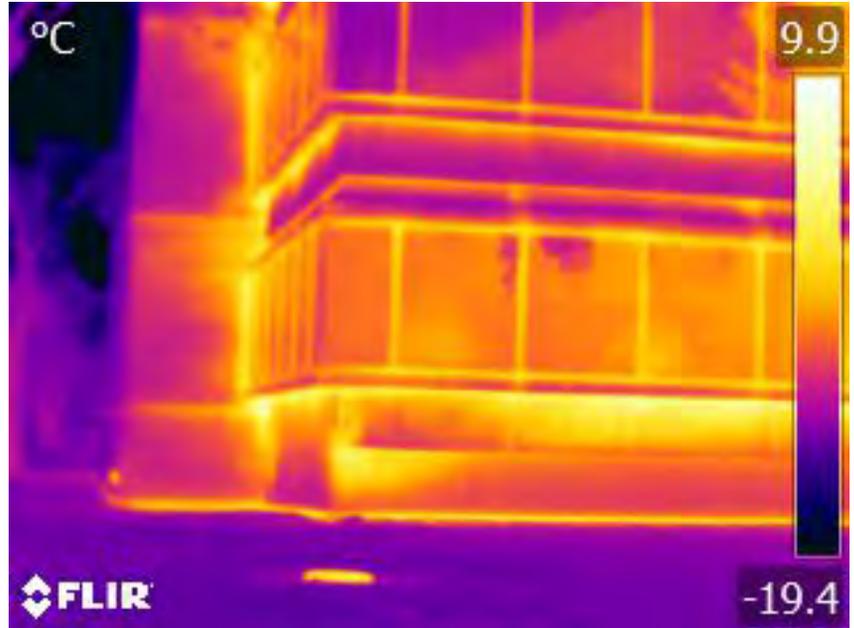
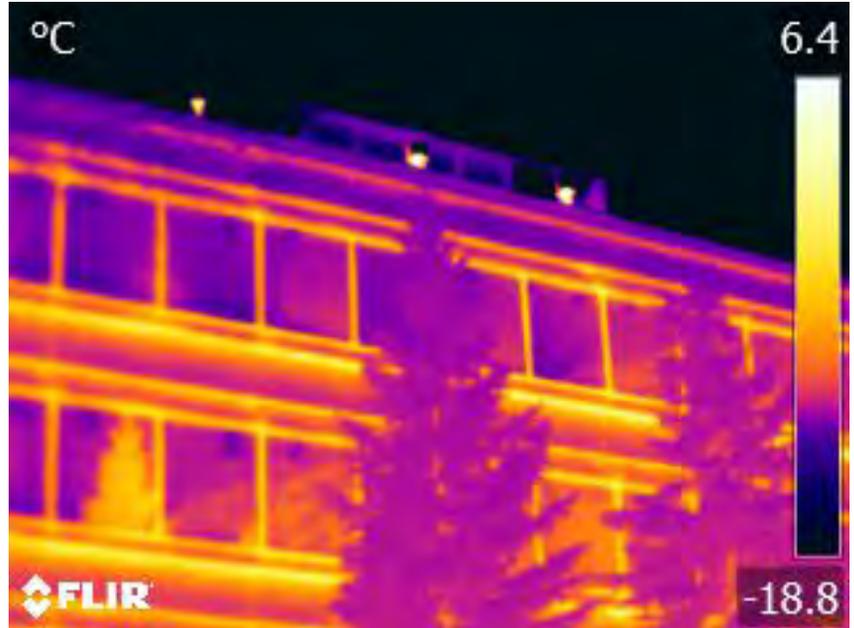
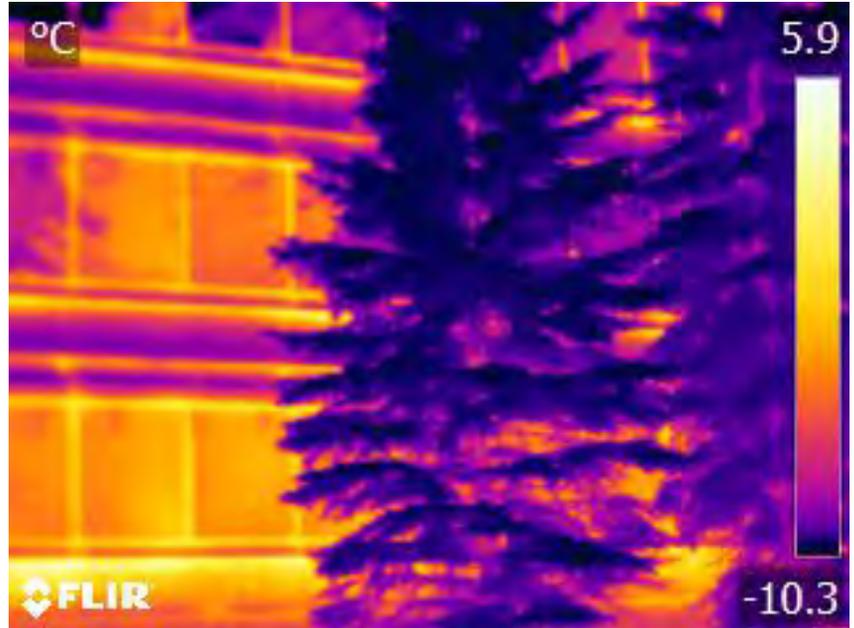
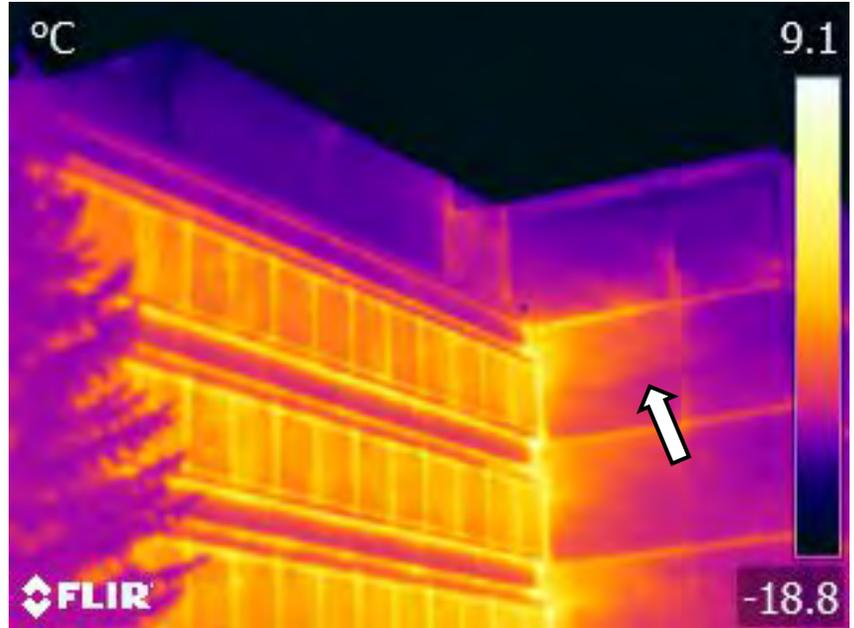
Partial east and north elevations. Note thermal anomalies around window framing caused by air leakage.

Detail view of north elevation at east end. Note thermal anomalies caused by air leakage at and around window framing.

Detail view of north elevation at east end near grade. Note thermal anomalies caused by air leakage at and around window framing.

Detail view of north elevation.  
Note thermal anomalies caused  
by air leakage at and around  
window framing.

Detail view of north elevation at upper west end. Note thermal anomalies caused by air leakage at and around window framing.

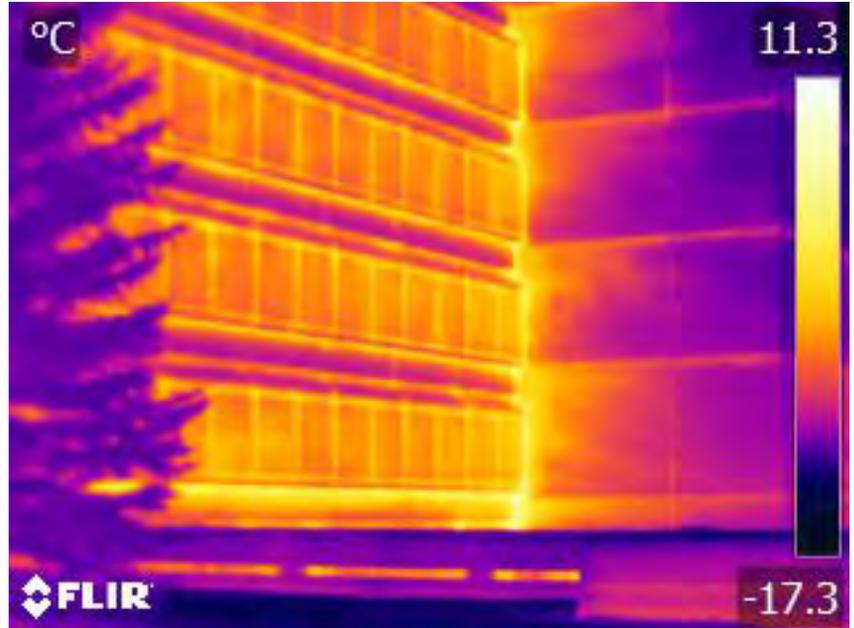
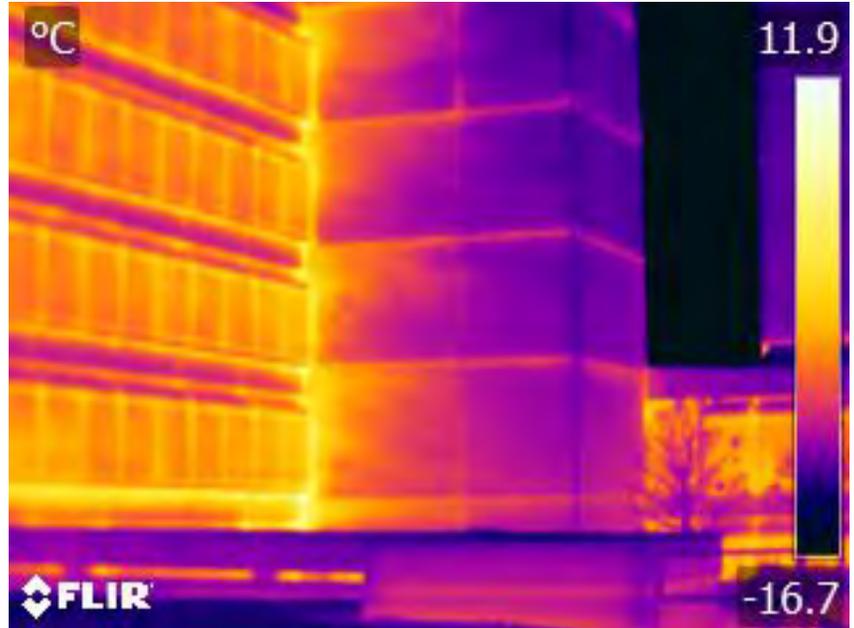
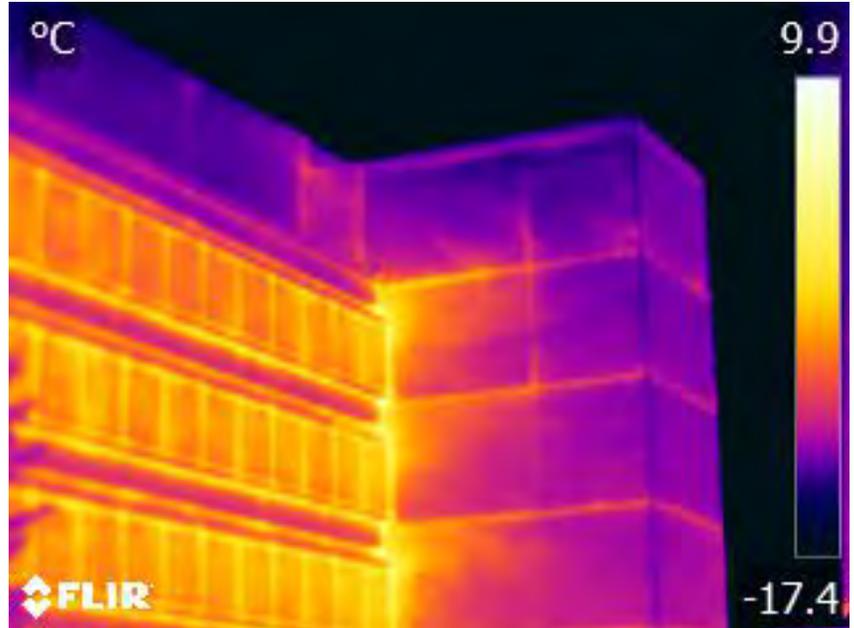
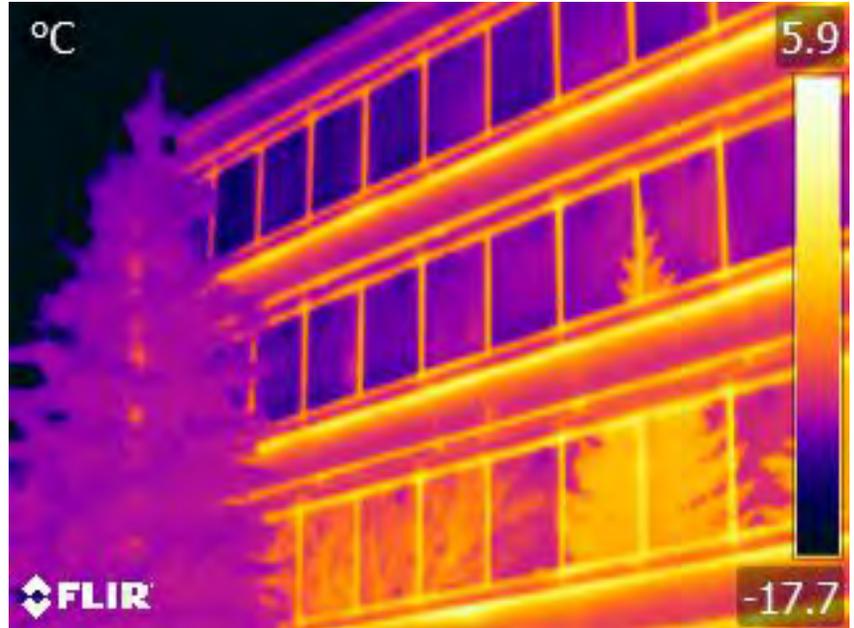
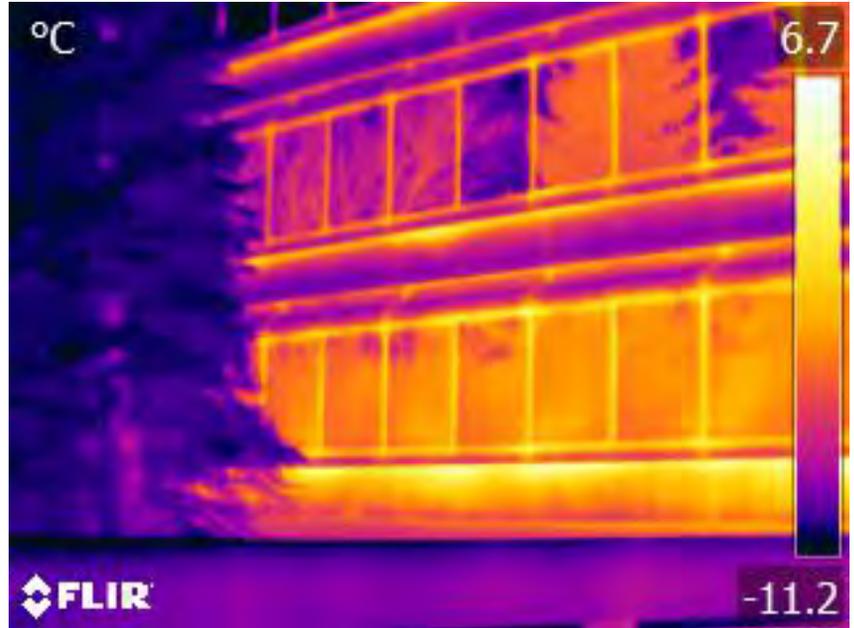
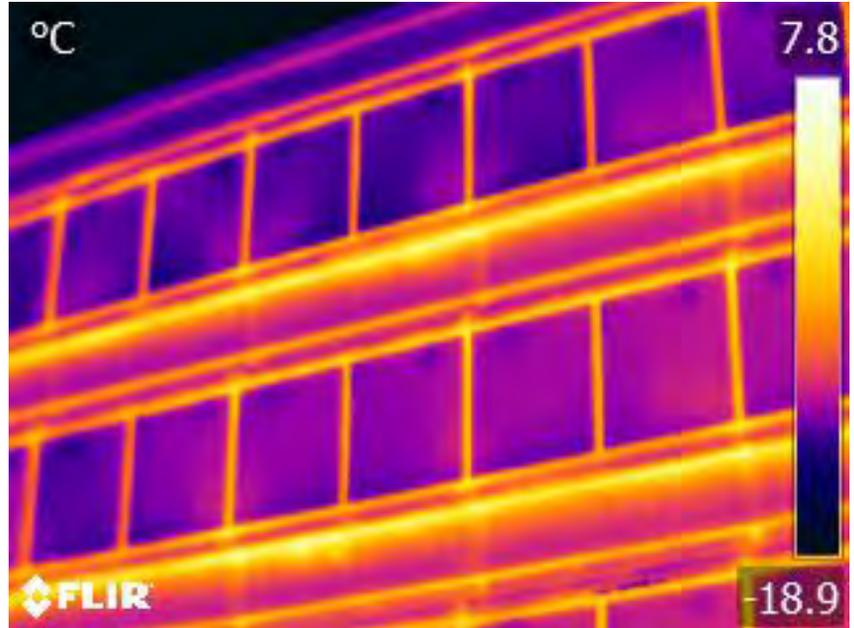
Detail view of north elevation at upper west end. Note thermal anomalies caused by air leakage at and around window framing.

Detail view of north elevation.  
Note thermal anomalies caused  
by air leakage at and around  
window framing.

Remediation of the overall exterior wall assembly including air sealing measures and rehabilitation, or replacement of window and curtain wall components is recommended to minimize air leakage, reduce operating costs, improve occupant comfort, lessen the potential for damage to structural components and enhance the overall performance of the building enclosure.
